## **DISCLAIMER: Second-Hand Plant Condition and Safety**

MHE-000117 / 124192 / Lucas Skinner / 24/12/2025 / Jungheinrich / EFG218K

### Truck Category

Category 3 - Electric  
Counterbalance

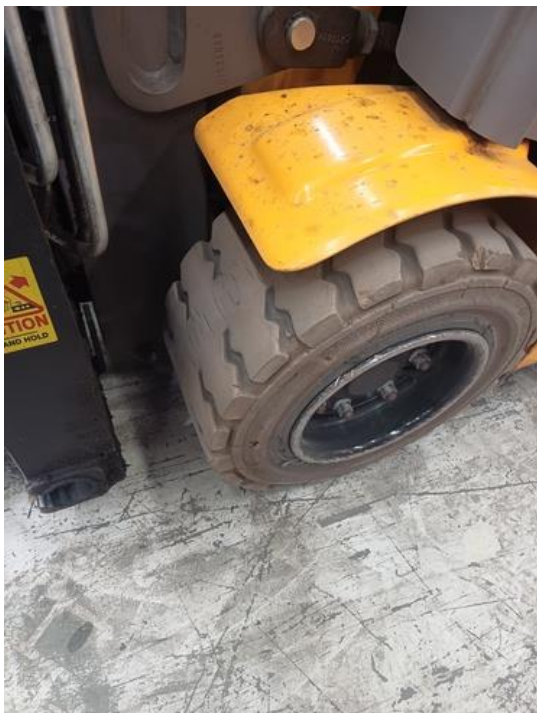
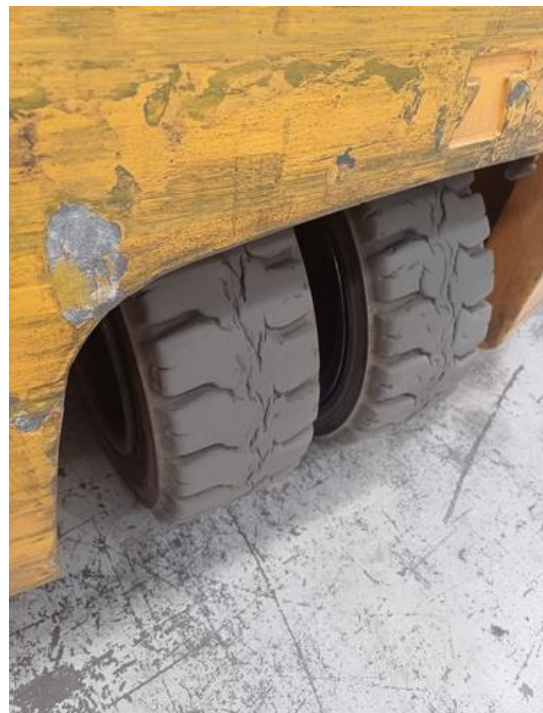
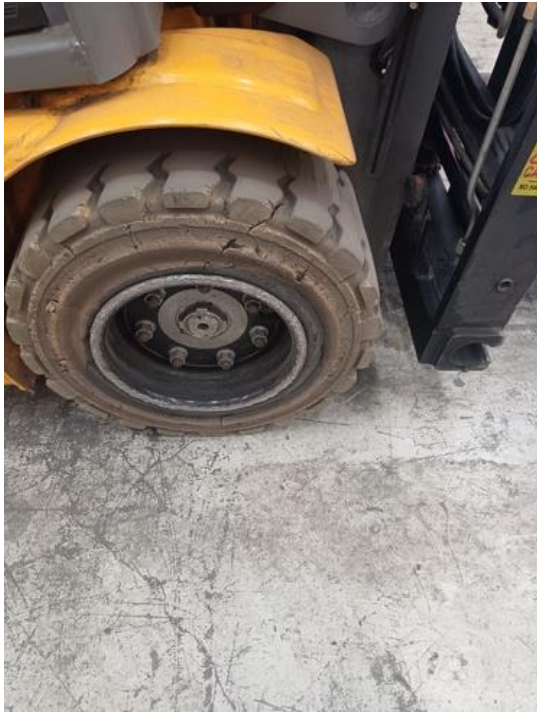
Seat switch and seat belt switch fitted to check presence of operator & working in sequence?	Yes
Seat is secure and seat belt is in serviceable condition?	Yes
Mast switch operation for travel speed reduction to 3kmh above specified height	Yes
Are brakes and park brake functioning correctly?	Yes
Are tyre treads within limits and/or free from damage?	No
<div>

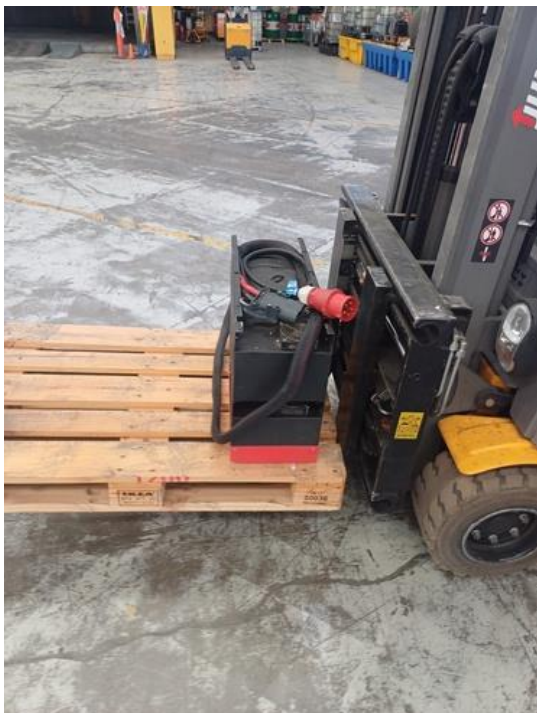
Photo 15

Charger not tested, Fitted with euro plug.

Forklift fitted with aftermarket battery
