Used Sale Safety & Compliance Check

MHE-000153 / 131386 / Udesch Ganepola / 21/01/2026 / Jungheinrich
/ EFG218

| Model | EFG218 |

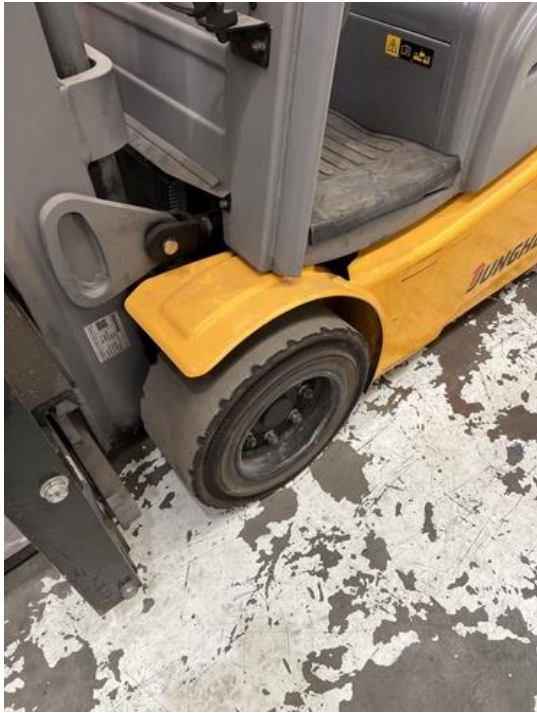
Photo 5

| Truck Category | Category 3 - Electric Counterbalance |
|---|---|
| Are tyre treads within limits and/or free from damage? | Yes |

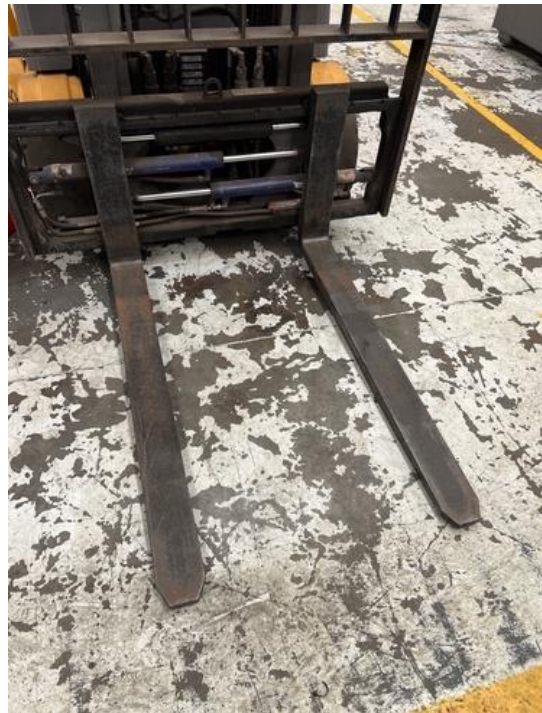
Photo 8

| Truck Category | Category 3 - Electric Counterbalance |
|---|---|
| Are fork tyres in good condition and within specification? | Yes |

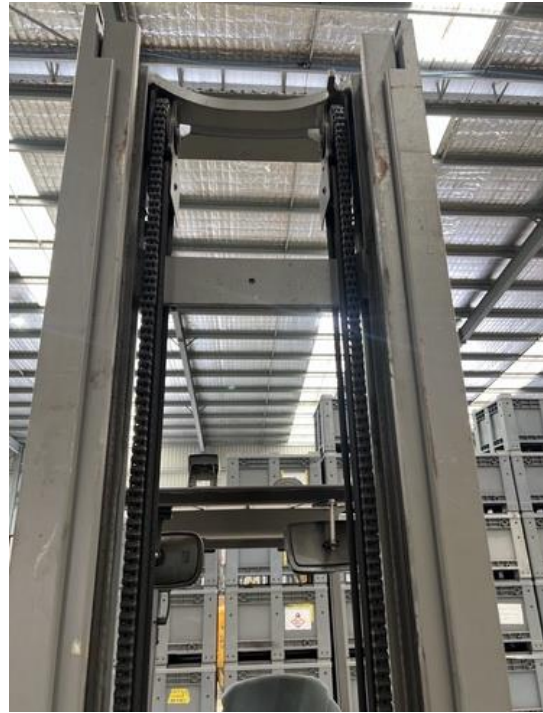
Photo 10

| Truck Category | Category 3 - Electric Counterbalance |
|---|---|
| Are mast chains in good condition, within specification and working correctly? | Yes |
