MOTOR BOAT PRE PURCHASE

CLIENT'S NAME:	
DATE OF INSPECTION:	08/04/2020
SITE:	Sandbrook Inlet Marina, NSW
VESSEL DESIGN:	Halvorsen 25, Launched 1949
REGO NO:	NA990N
HIN:	AUWWA196185GV7
GENERAL DESCRIPTION:	Traditional timber cruiser
CONSTRUCTION:	Traditional carvel planked timber

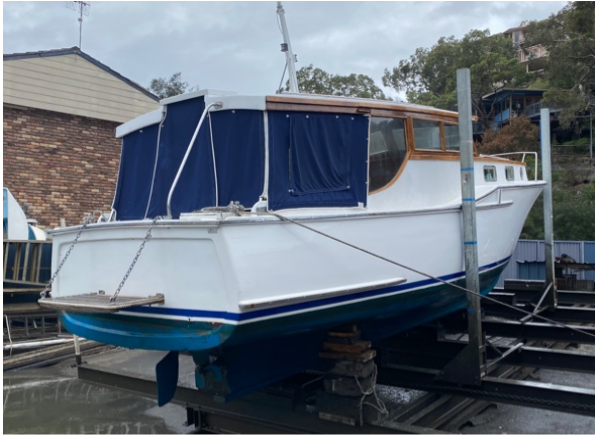
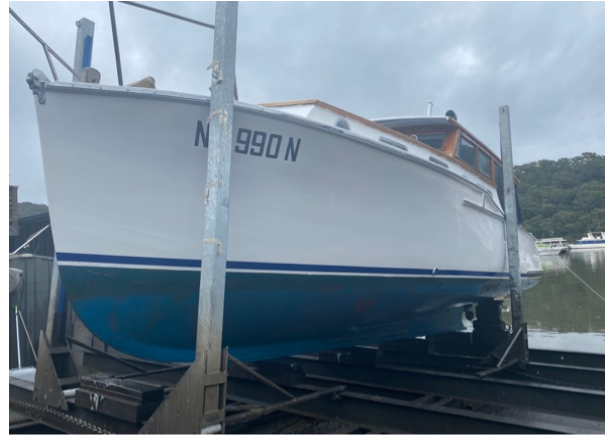
TOPSIDES:	Good condition, minor seam movement and splitting evident. Maintain paint protection at all times. Last re painting process to bare timber in 2015
BOTTOMS:	Various areas have been epoxy filled and secure including the garboard plank seam to keel. There is an area amidships on the starboard side where 2 planks appear to have sprung. The area inside the lazerette and transom needs to be cleaned out and sealed to prolong life expectancy. There is an area near the stem on starboard side that has some export filler coming away and timbers furry.
ANTIFOULING:	Reapplication due
HULL AND DECK JOIN:	Structurally sound
KEEL AND FIXINGS:	New docking strip fitted recently
RUBBING STRIP:	Good condition
BULKHEADS AND BONDINGS:	Good condition
OTHER:	Remove all debris as shown and prime and paint all accessible areas to prolong life expectancy. Annual slipping and paint protection key to prolonged life expectancy

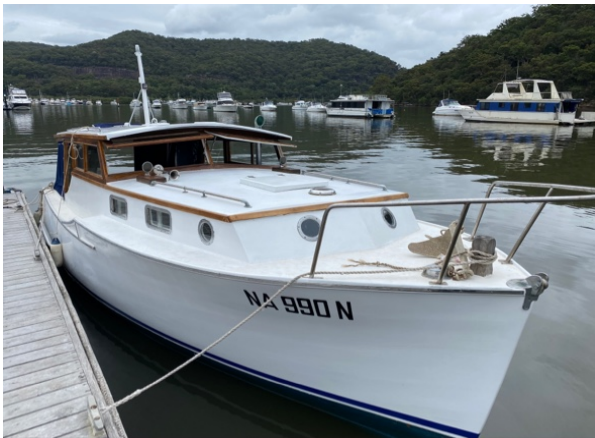
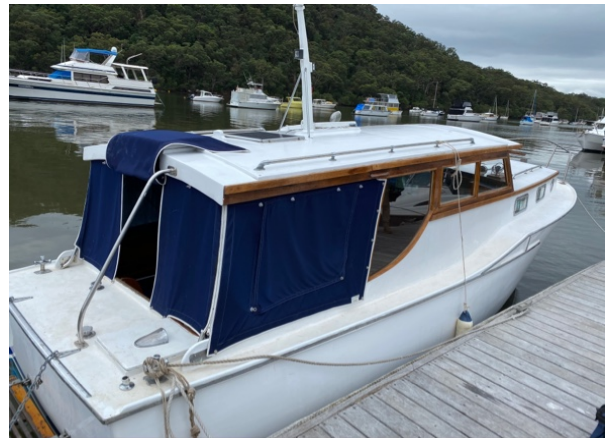
CABIN SIDES:	Structurally sound, precious repairs noted and sound
CABIN TOP:	Structurally sound, new brow section fitted not professional but sufficient
DECK STRUCTURE:	Epoxy sheathed and sound, prime and paint area in anchor locker.
BOW RAIL:	Secure, check and seal at regular intervals
BULWARKS:	Structurally sound

HATCHES AND PORTS:	Rot noted on foredeck hatch
WINDOWS AND SCREENS:	Good condition
CLEATS:	Secure
COCKPIT SEATING:	Good condition
OTHER:	Installation of additional ventilation recommended for air flow and allowing vessel to breath

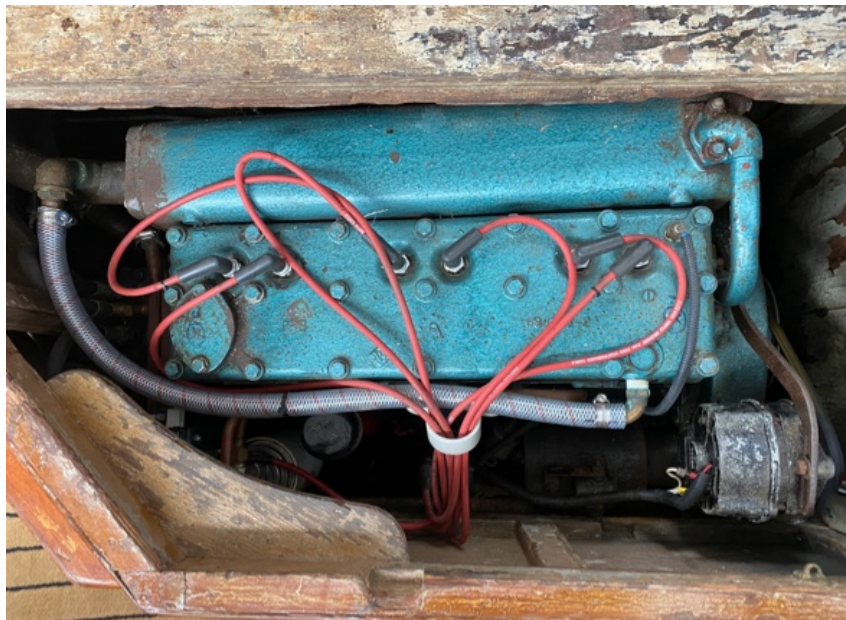
MAKE AND MODEL:	Main Engine: 6 Cyl Chrysler Petrol
SERIAL NO:	1204677
HRS:	Unknown
OIL LEVEL:	Good
OIL CONDITION:	Clear
EXHAUST SYSTEM:	Operational
HOSES ECT:	Good
HOUSING:	Good
FILTERS:	Good
GEAR BOX OIL:	Clear
SHIFT CABLE:	Smooth
THROTTLE CABLE:	Smooth
OTHER:	Motor required choke to start, once running ran without faults. Ensure bilge blower is running and sniffer is clear before starting.
