# Boat State & First Mate

Reference: RB648

Type of Survey: Insurance - Out of water survey

### **That's Amore – Gobbi 335 SC.**

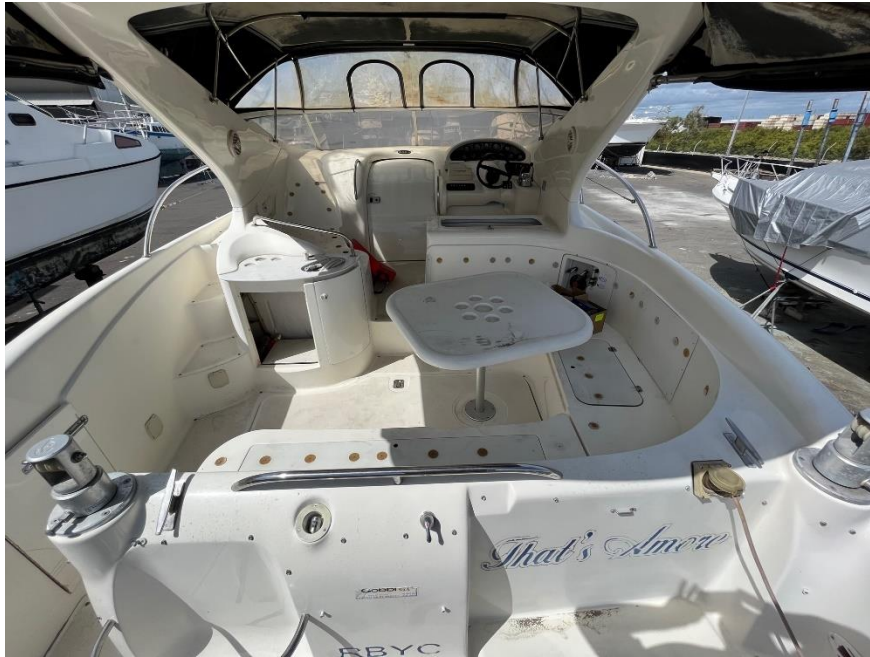
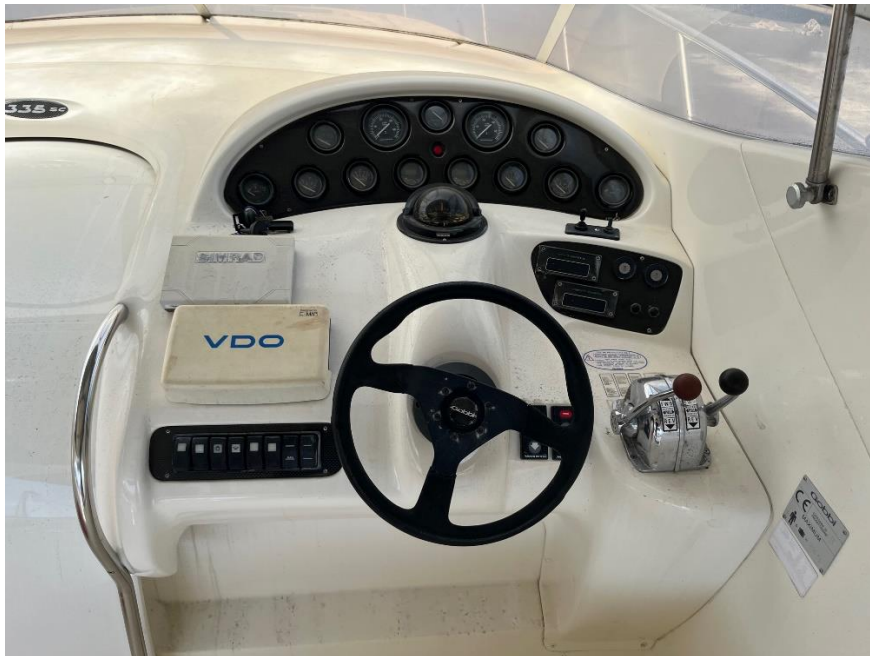
Condition	Comments
Gelcoat & Non-Skid Surfaces:	Satisfactory	All gelcoat and non-skid surfaces are in reasonable condition and once they have been pressure cleaned and detailed it will make a huge difference to this boat. No structural damage to the gelcoat and non-skid surfaces just requires some TLC.
Cleats:	Good	All cleats are tight and well secured to the deck. Well-sealed and no signs of water leaking through cleats. No defects found.
Transom Door:	Satisfactory	Transom door opens, closes, and locks correctly. No binding or stiffness in door. Locks in the hold open position as well. Crack in transom door. (See picture 5 on page 13).
Stainless Steel Grabrails:	Satisfactory	All tightly secured and sealed to boat. No defects found.
Bimini & Extension:	Poor	The Bimini and extension are in poor condition and require replacing. (See picture 6 on page 13).
Clears:	Poor	The clears are very stained and sun damaged. (See picture 7 on page 13).

Lights:	Satisfactory	All cockpit lighting tested and working. No dull or blown bulbs.
Cabin Sliding Door:	Satisfactory	Sliding door is a little stiff to slide open and closed. Some lubrication spray will help to free it up. Door locks as required. No defects found with door and locks.
Cockpit Lockers:	Satisfactory	All cockpit lockers open and close smoothly and locker frames tightly secured to boat. All of the vessels structural components are in good condition with no delamination, cracks or damage found including transom area of the vessel.
Cockpit Floor:	Satisfactory	Non-skid cockpit floor in cockpit and helm station is in good condition with no major dents, damage, splits, or defects found. Gelcoat requires a good wash down.
Engine Room Access Hatch:	Satisfactory	Hatch opens and closes smoothly. No defects found.
Table & Lounges:	Satisfactory	<p>The table is tightly secured to the floor. The table has some crazing in the gelcoat. (See picture 8 on page 13).</p> <p>The lounge is always covered and also presents in as new condition. No defects found.</p> <p>All lounge cushions have been removed from the vessel to be re-upholstered.</p>

Fridge:	N/A	The cockpit fridge has been removed and blank space for fridge is empty. (See picture 9 on page 13).
