SLIPSTREAM
MARINE
BOAT SURVEYING

MOTOR BOAT PRE PURCHASE

CLIENT'S NAME:	
DATE OF INSPECTION:	16 July 2024
SITE:	Kirribilli and Noakes Boatyard, NSW
VESSEL DESIGN:	1989 Ranger 47 - 1E 20 PAX - 2 Crew. Expires 14/09/2028
REGO NO:	AMSA UVI: 422962 & 18246 (Displayed)
HIN:	Not required for commercial vessels
GENERAL DESCRIPTION:	Flybridge Cruiser
CONSTRUCTION:	Composite GRP with Timber Fitout

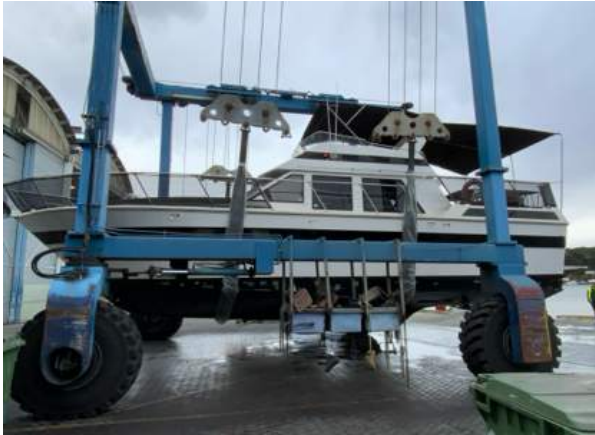
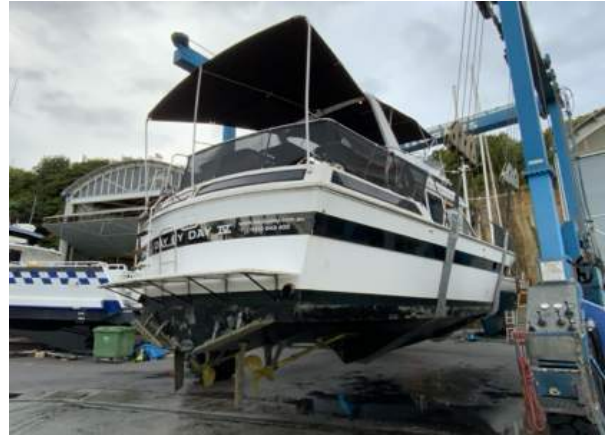
TOPSIDES:	Structurally sound with general wear and tear
BOOT STRIPE AND GUNNEL BAND:	Acceptable with general wear and tear
BOTTOMS:	Structurally sound with general wear and tear
ANTIFOULING:	Worn to primer in areas
OSMOSIS:	Blisters present and as expected, no concerns to structure
HULL AND DECK JOIN:	Structurally sound and secured
KEEL AND FIXINGS:	No damage noted
RUBBING STRIP:	Secured with general wear and tear
BULKHEADS AND BONDINGS:	Further investigations needed for engine room aft bulkhead crack at starboard bearer Timber decay at port lower saloon & hull intersestion
PORTS AND WINDOWS:	Various leaks noted
BOARDING OR SWIM PLATFORM	Existing damage present and fasteners missing from support to board
ENGINE BEDS	Structurally sound with general wear and tear
STRINGERS	Structurally sound with general wear and tear
NON DESTRUCTIVE TESTING	Hammer tested and sound
CHINES	Acceptable with general wear and tear

BOARDING PLATFORM SUPPORT	Secured to hull, fastenings missing at boarding platform
TRANSOM	Structurally sound with general wear and tear
STEM	Structurally sound with general wear and tear

22. Out of water and under water maintenance due
23. Repair areas around freeing ports on hull
24. Replace starboard rudder bearing at next out of water period

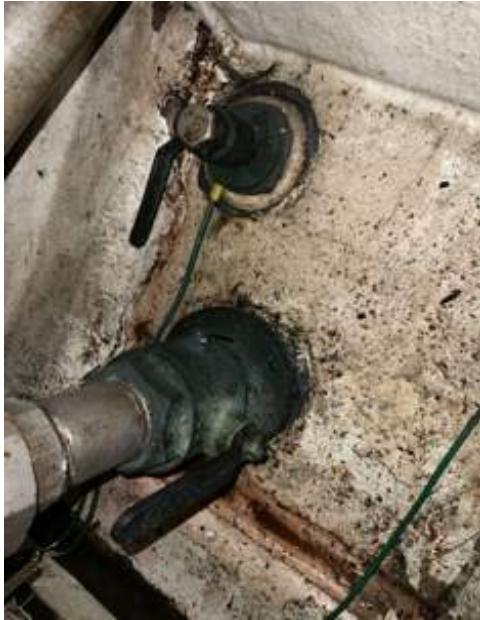
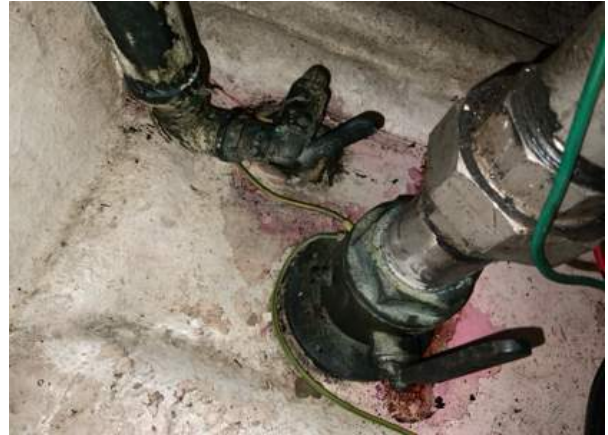
TOILET INTAKE FWD:	Secured and operational, corrosion noted and recommended for replacement at next out of water period
TOILET OUTLET FWD:	Deck connection only
THROUGH HULL TRANSDUCERS:	Secured and operational
ANCHOR LOCKER DRAIN:	Self draining and clear
ENGINE INTAKE:	Secured and operational
GENERATOR INTAKE	Secured and operational
GENERATOR EXHAUST	Secured and operational

1. Replace forward toilet intake through hull fitting and valve at next out of water period
2. Detail and corrosion guard sea water intake located under galley floor access panel

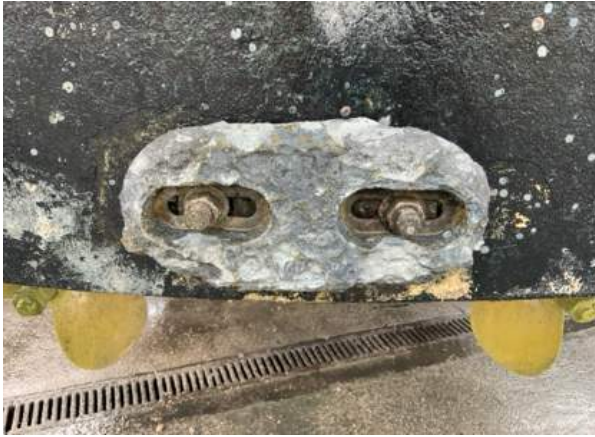
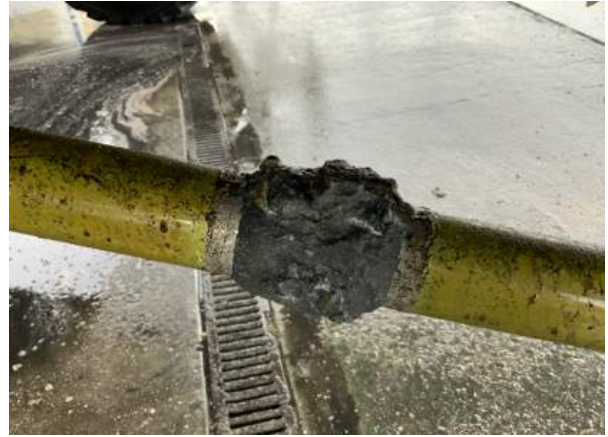
HULL ANODES:	Active
SHAFT ANODES:	Active
EARTH OR BONDING STRAP:	Various connections down
BOWTHRUSTER ANODES:	Active

OTHER:	Anode wear acceleration noted, reinstate bonding system and retest
--------	--

20. Rectify bonding system connections (various system connections broken) and investigate earth leaks (anode wear high)
21. Investigate further - crack at aft engine bulkhead in line with inboard starboard engine bearer

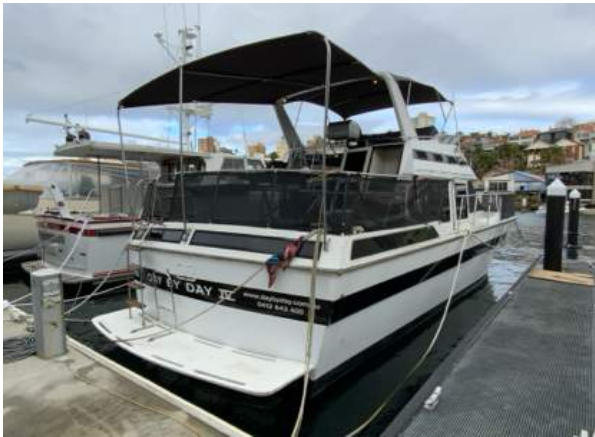
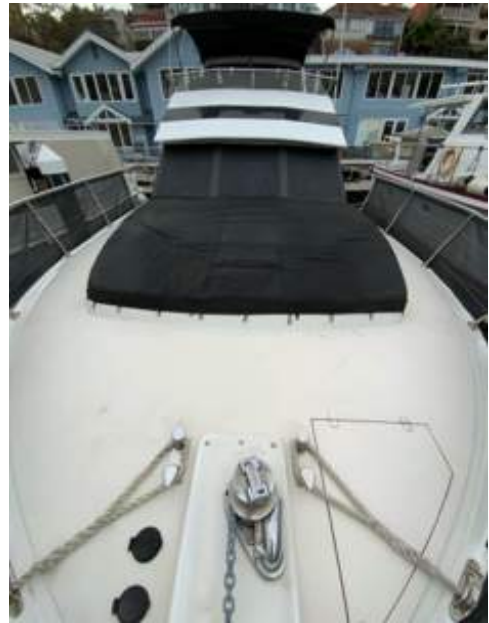
CABIN SIDES:	Structurally sound with general wear and tear Areas around windows damp with internal linings with timber decay
CABIN TOP:	Structurally sound with general wear and tear
DECK STRUCTURE:	Structurally sound with general wear and tear Higher levels of moisture noted on foredeck area Note: Aft cockpit has been upgraded
FLYBRIDGE STRUCTURE:	Structurally sound with general wear and tear
BOW RAIL:	Various fasteners require upgrading
BULWARKS:	Freeing poirt areas water damaged and cracked
GRAB RAILS:	Various units to be refastened
HATCHES AND PORTS:	Secured and weathertight
WINDOWS AND SCREENS:	Various leaks noted with internal waterdamage
ANCHOR WINCH MOUNTINGS:	High levels of moisture noted Timber spacer between bowsprit and deck waterlogged and perishing
ANCHOR:	Acceptable with general wear and tear
ANCHOR CHAIN AND WARP:	Acceptable with general wear and tear

BOW FITTINGS AND ROLLERS:	Secured with moisture damage to bow sprit in areas
CLEATS:	Secured and undamaged
COCKPIT SEATING:	Acceptable with general wear and tear
FLYBRIDGE SEATING:	Acceptable with general wear and tear
LOCKERS AND LATCHES:	Acceptable with general wear and tear
COMPANIONWAY DOORS	Secured and weathertight
FLYBRIDGE WINDOWS	Acceptable with general wear and tear

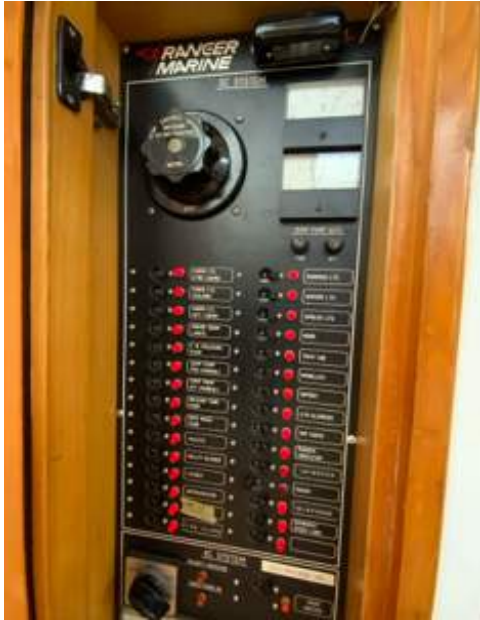
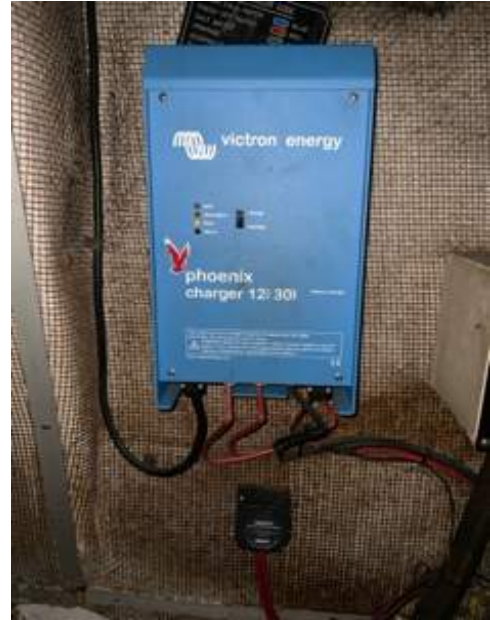
BATTERIES:	Tested operational
DISTRIBUTION PANEL:	Tested operational
SALLOON LIGHTS:	Various units faulty
FWD CABIN LIGHTS:	Various units faulty
AFT CABIN LIGHTS:	Various units faulty

GALLEY LIGHTS:	Various units faulty
HEAD LIGHTS FWD:	Tested operational
HEAD LIGHTS AFT:	Various units faulty
NAV LIGHTS:	Tested operational, stern light should be mounted vertically
ANCHOR LIGHT:	Various units faulty
COCKPIT LIGHTS:	Various units faulty
ENGINE BLOWERS:	Operational, but extremely noisy
STEREO:	Various units faulty
ANCHOR WINDLASS:	Tested operational (foot switches not operational or decommissioned)
DEPTH:	Tested operational
LOG:	Tested operational
VHF RADIO:	Tested operational
TOILET FWD:	Tested operational
TOILET AFT:	Faulty
SHOWER SUMP FWD:	Decommissioned
SHOWER SUMP AFT:	Decommissioned
WATER PRESSURE:	Tested operational
BILGE PUMPS:	Tested operational , no audible alarms
BOWTHRUSTER:	Tested operational
HORN	Tested operational
ENGINE ROOM LIGHTS	Faulty

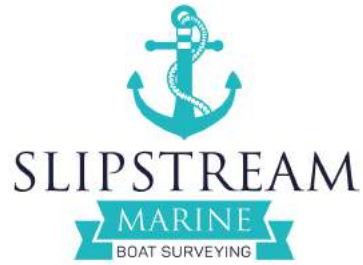
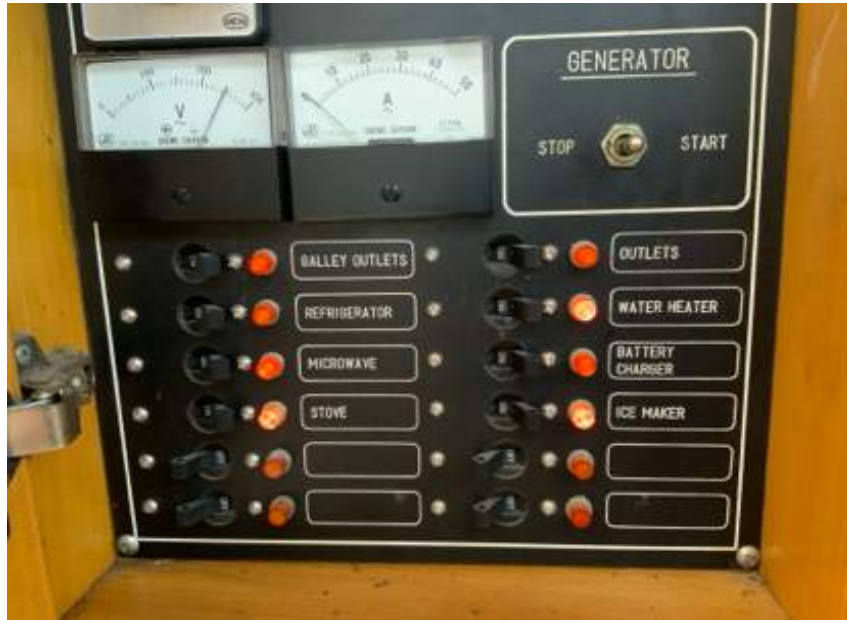
POWER POINTS:	Various units faulty or decommissioned
BATTERY CHARGER:	Tested operational
HOT WATER SYSTEM:	Tested operational
LIGHTING:	Various units faulty or decommissioned
FRIDGE:	Domestic type fitted and operational
SHORE POWER LEAD:	Domestic type fitted
MICROWAVE:	Tested operational
TV:	Tested operational
RCD FITTED:	Update to modern standards adviseable
DISTRIBUTION PANEL:	Tested operational

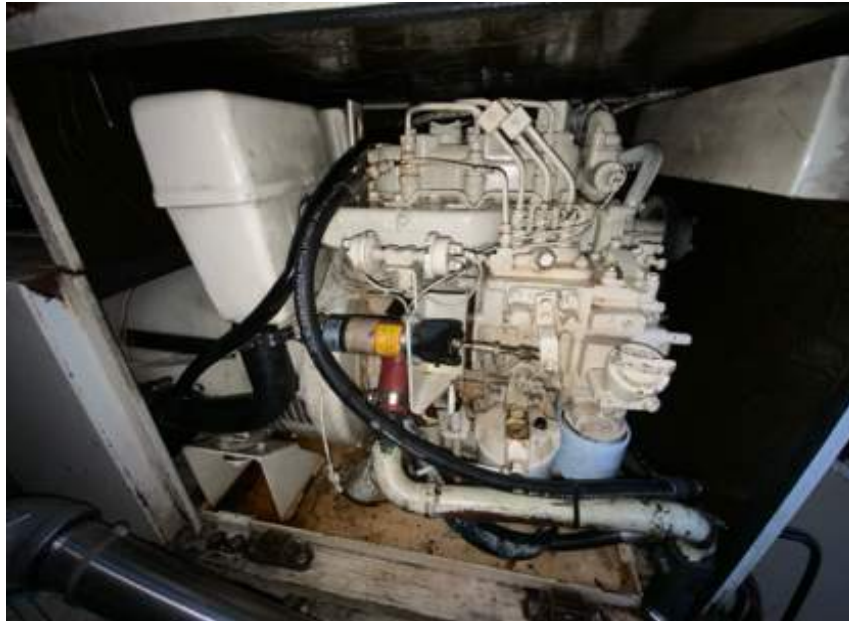
OTHER:	Unable to start, requires new fuel transfer pump and re-testing
--------	---

15. Replace fuel transfer pump on generator and retest
16. Rectify leak at Hotwater tank in engine room
17. Repair port engine room fire detector fitting

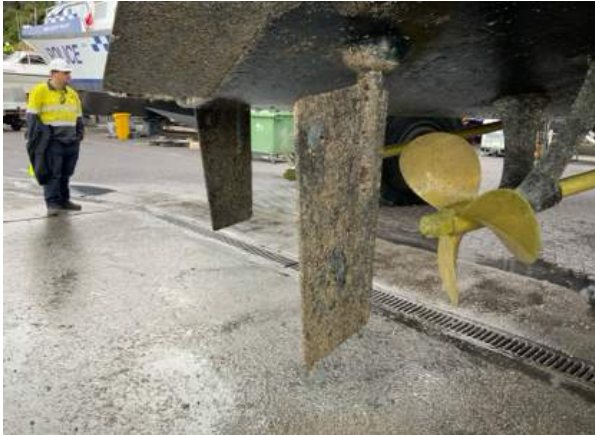
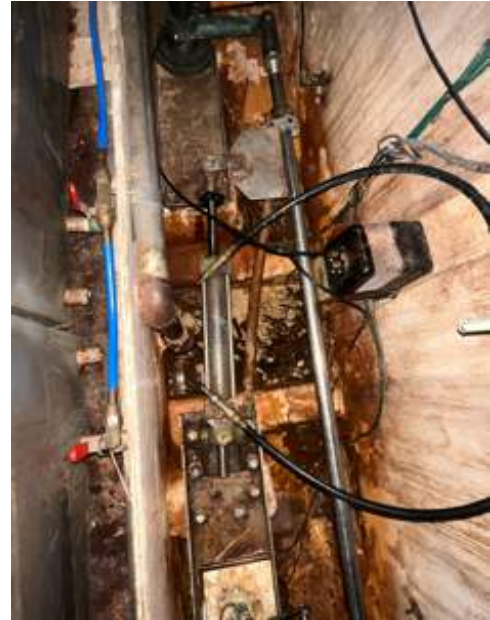
HYDRAULIC RAM:	Secured and operational
WHEEL:	Secured and operational
RUDDERS:	No damage noted
RUDDER GLANDS:	No leaks noted
EMERGENCY TILLER:	Located in aft cabin
HYDRAULIC LINES	No leaks noted
RUDDER ANGLE INDICATOR	Adjustments required

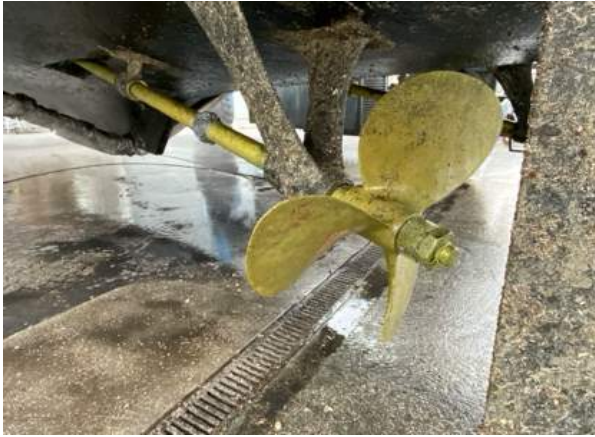
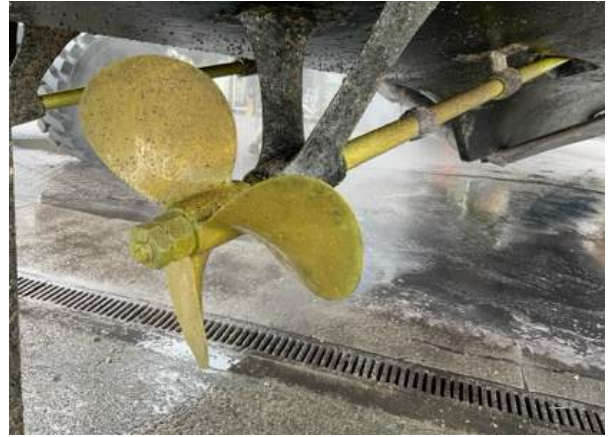
PROPELLORS:	No damage noted
PROPELLOR SHAFTS	Shafts have been metal sprayed and cortosdion at gland area leading to wear
STERN GLANDS:	New units with minor leaks beggining due to corrosion on shafts at gland area
SKEG & BEARINGS:	Secured and undamaged
RUDDER BEARINGS:	Starboard side with excessive movement
TRIM TABS:	Secured and undamaged , not operational
BOW THRUSTER PROPELLER:	No damage noted

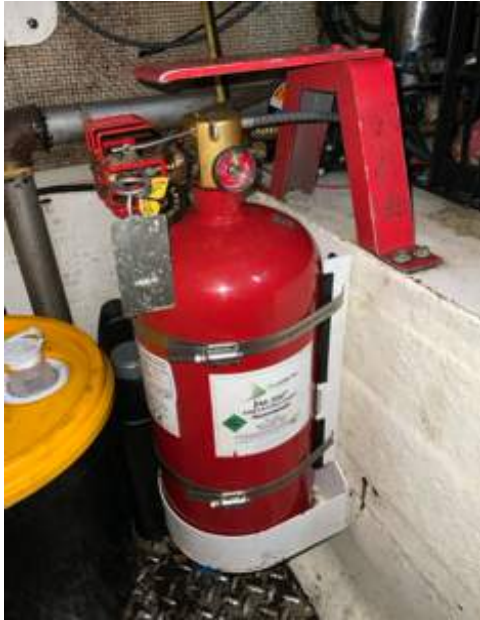
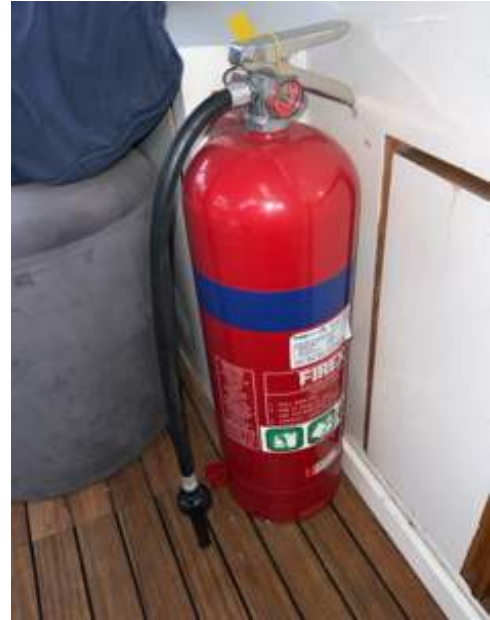
SUPPRESSION SYSTEM	FM200 Serviced 11/2023
EXTINGUISHERS	Serviced 11/2023
SMOKE DETECTORS	Port ER detector damaged
SERVICE	In date
