Inspection Type

Insurance re-newel

Princess 50

Coma II

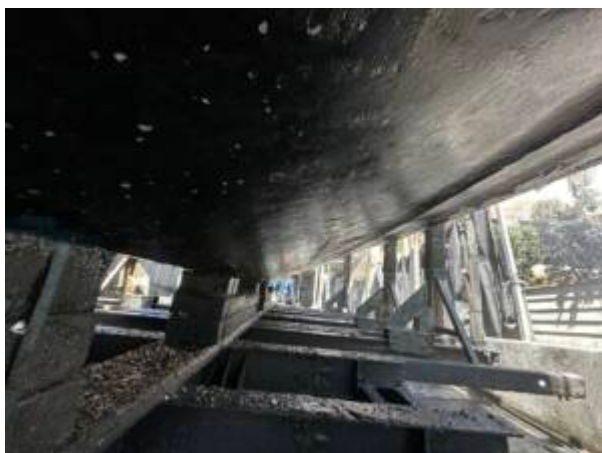
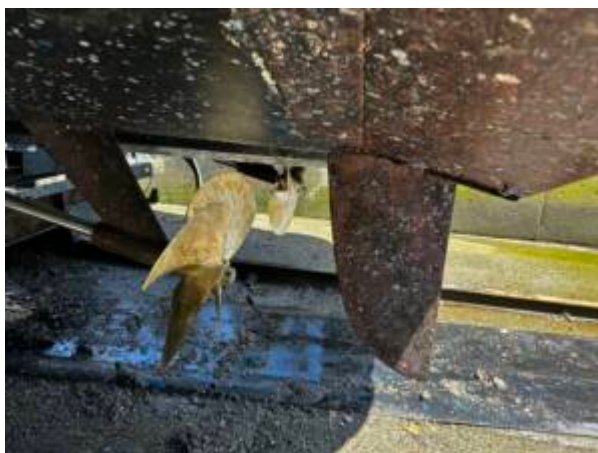
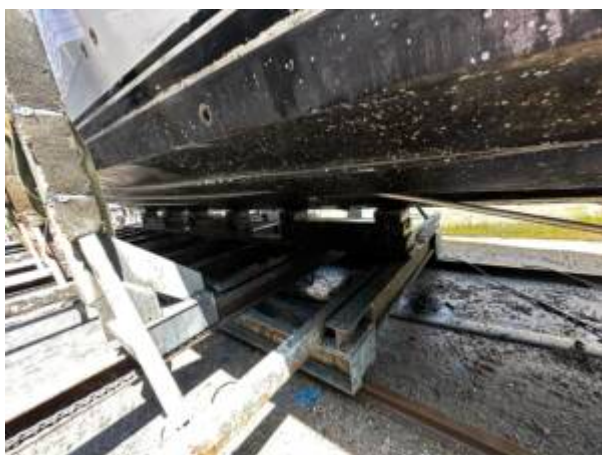
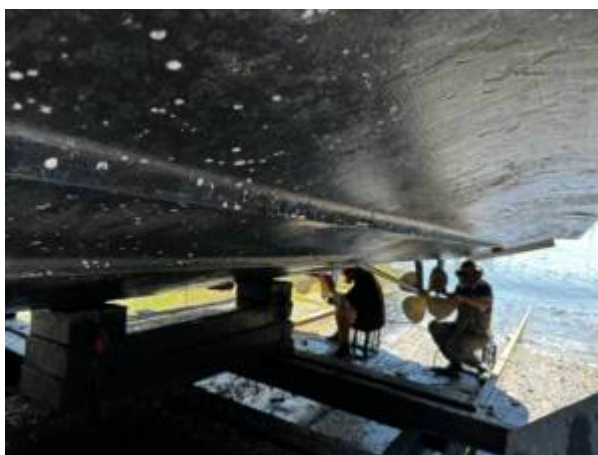
Propeller broken

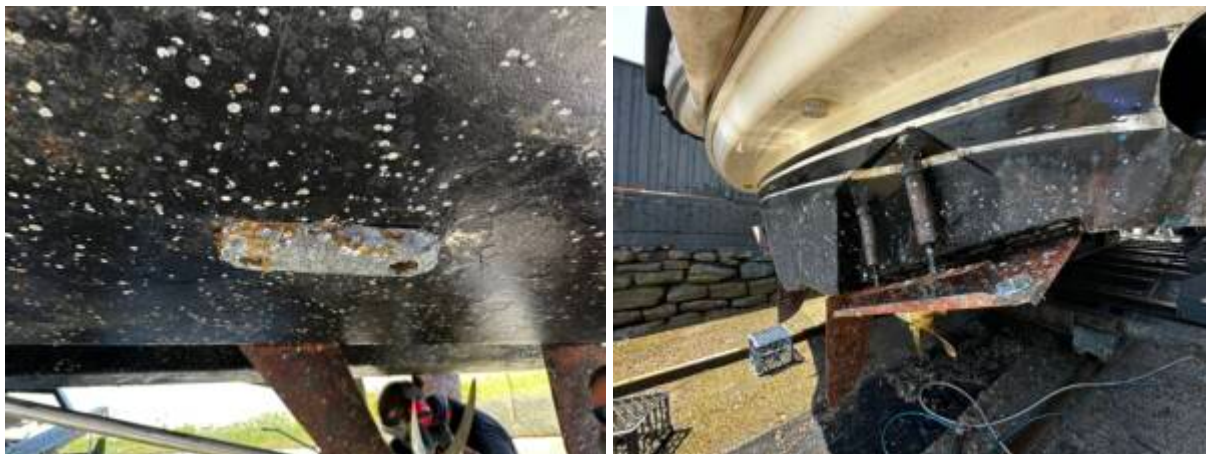
Good Condition

Depleted

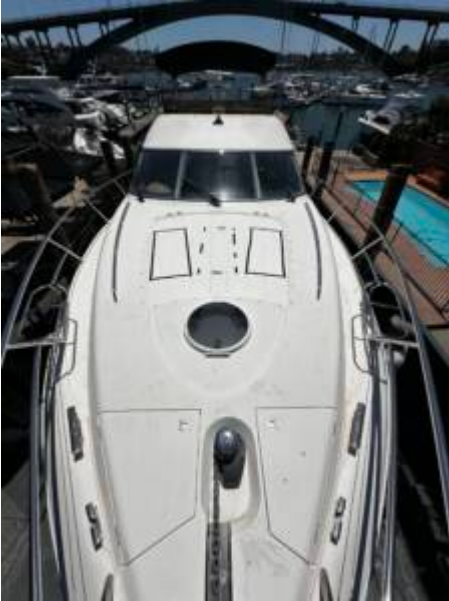
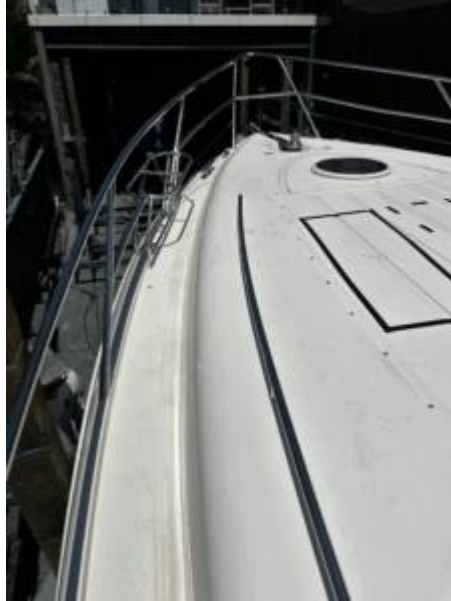
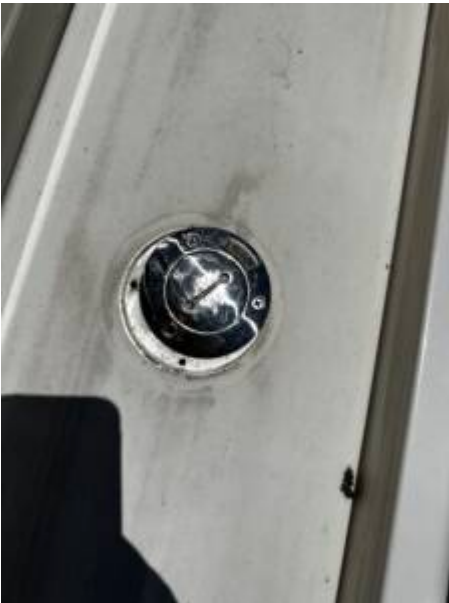
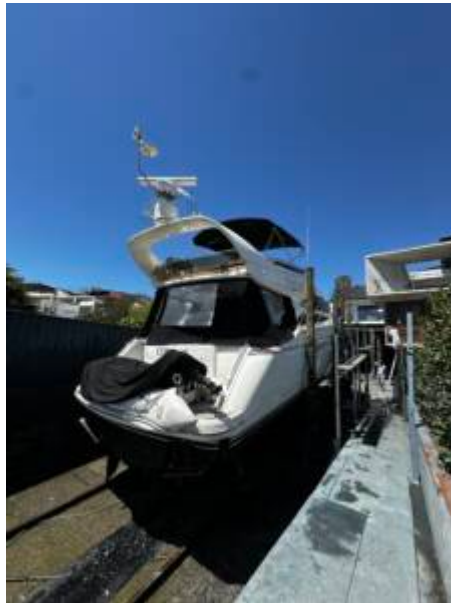
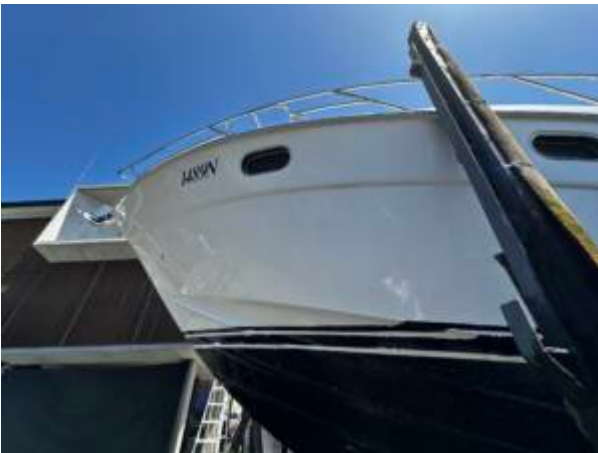
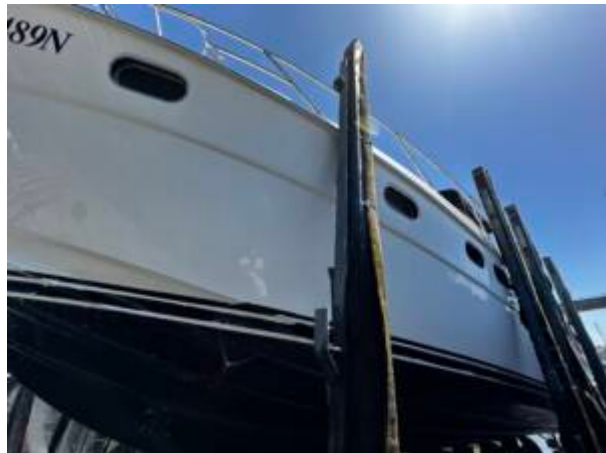
Seal previous holes for waste deck fitting

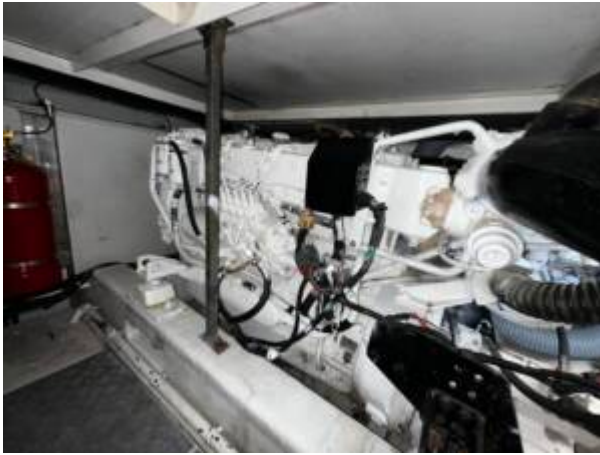
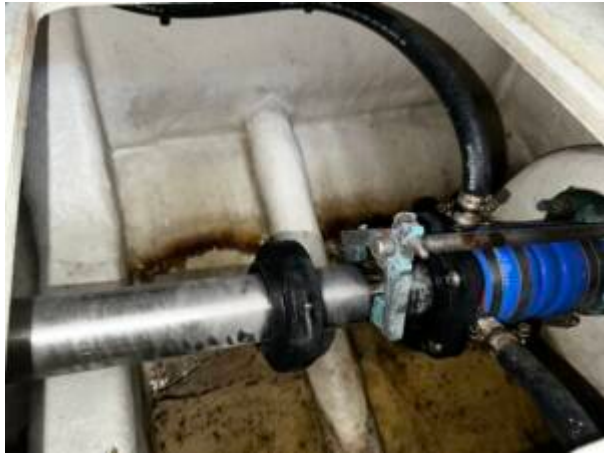
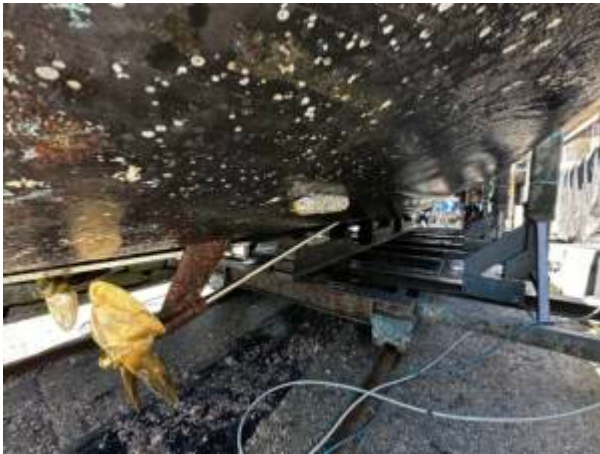
Non Accept

Exhaust tube at transom delaminating from

- Oil noted under engines. Clean bilge
- Re-glass engine exhaust tubes as delaminating from hull
- Horn inoperable

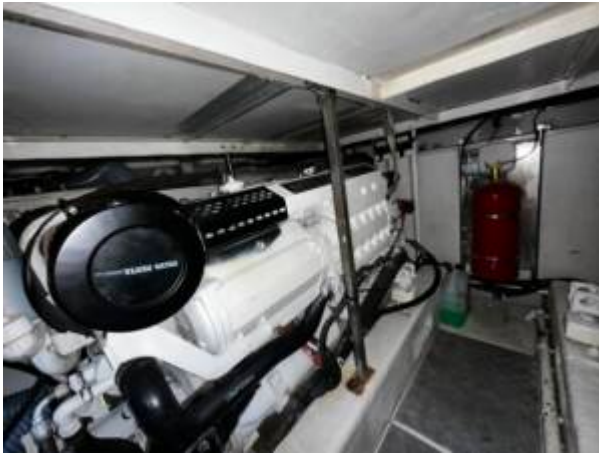
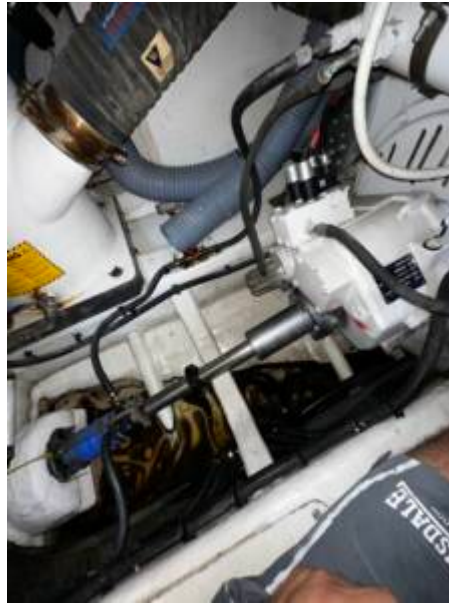
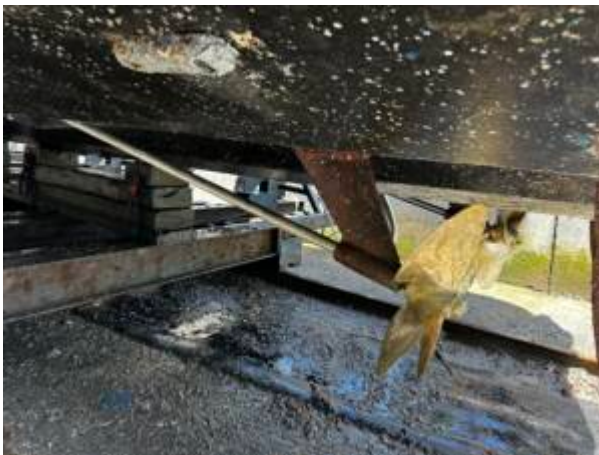
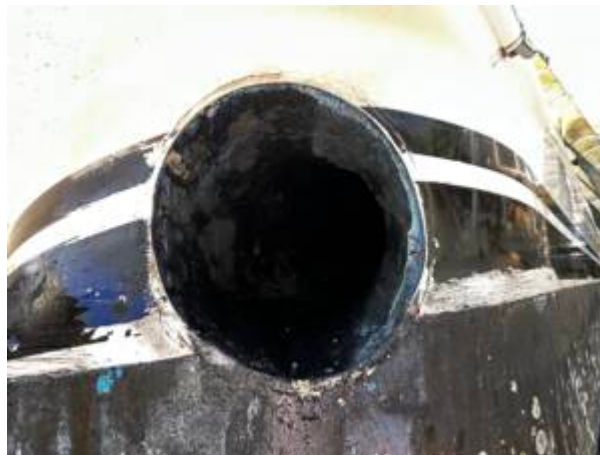
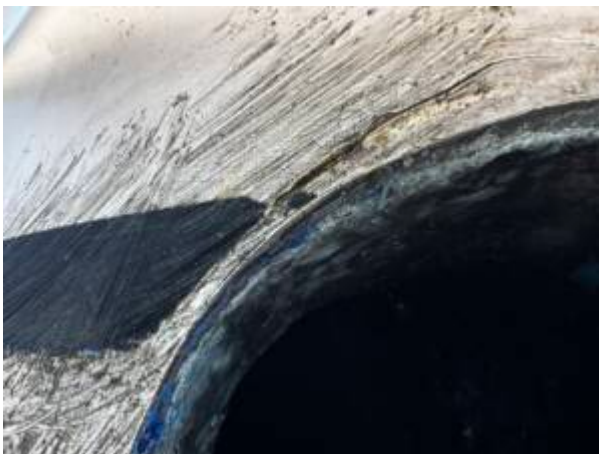
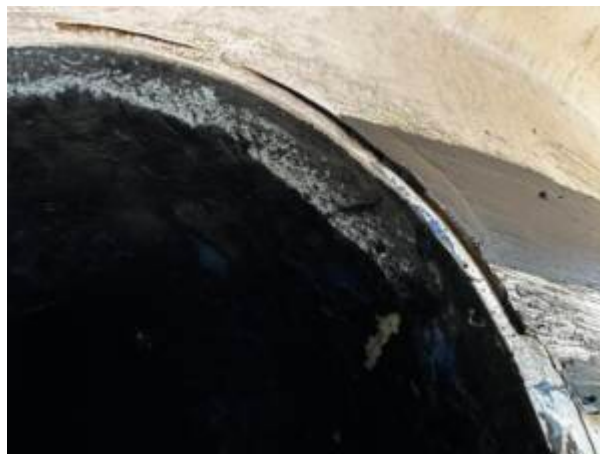
Non Accept

Exhaust tube delaminating from hull and leaking
