Insurance Survey – Sailing Yacht

TANGALOA

Inspected by: Kelvin Rabbitts
On 12 April 2024
Powder Hulk Bay NSW
Australia

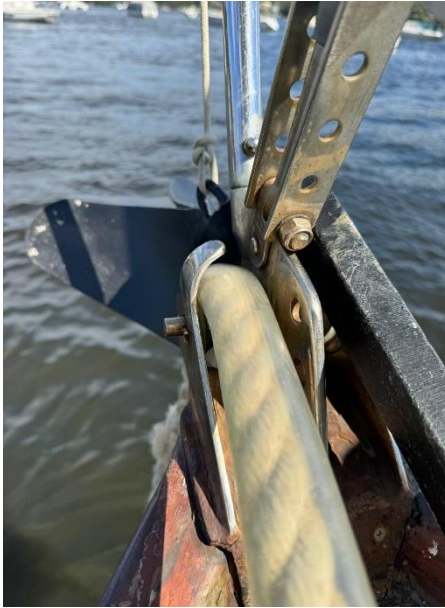
Secure bow roller stem fitting

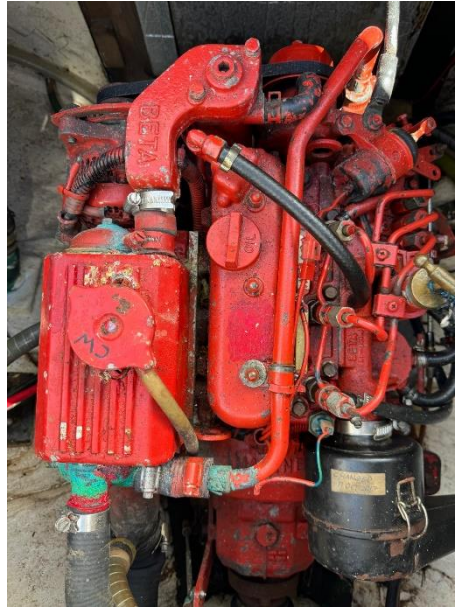
Diesel engine

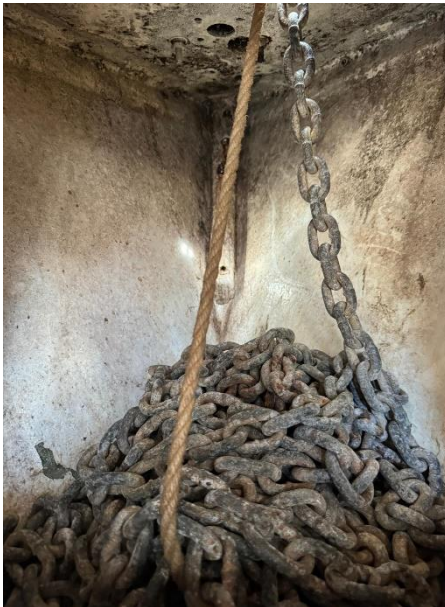
Good size ground tackle 1/2"

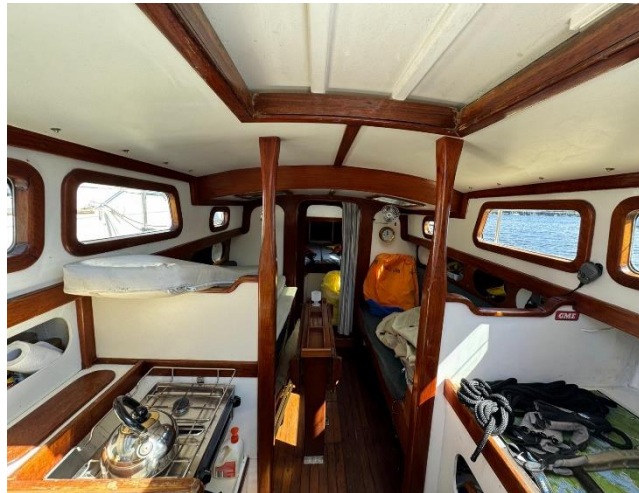
The fit-out was in good condition.

Fitout
