Mobile	Crane	Service	and	Inspection	Report

Tadano Demag AC55-1

Terex Demag AC55-1 SN 551066 Deferred Major Inspection

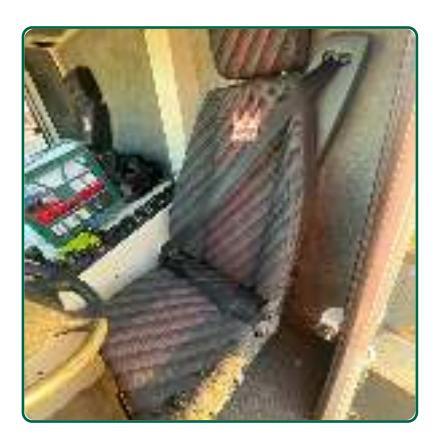
Passenger Door

Passenger door not closing and locking closed.

REMEDIED
