DISCLAIMER: Second-Hand Plant Condition and Safety

Used Sale Safety & Compliance Check

MHE-000295 / 124587 / Melbourne Service / 27/04/2026 /
Jungheinrich / EFG 320

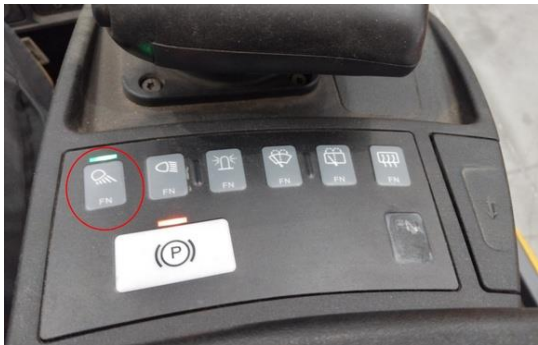
Photo 11

Are all controls inc. lift, tilt & sideshift/auxilliary functions working correctly

No

Light button is not working.

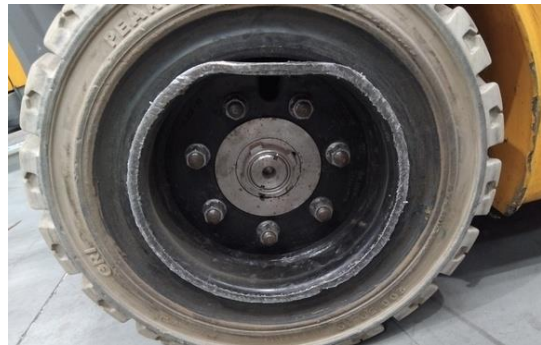
Photo 12

List any other notable defects or faults e.g. ROPS/FOPS damage etc.

- Left hand rims is bent.
- Free lift cylinder gland nut leaking oil.
