## Incoming Inspection Check

Serial Number	FN916183 15 - REACH TRUCKS
Hour Meter Read	2550 hr
Service Job No.	370136
Location	Sydney
Conducted on	22/01/2025 1:05 PM ACDT
Conducted By	Terry Pinchin
Truck Category	STR
Function	
Full function Test & Safety Check	Pass
Truck due for service?	No
Appearance	
Condition of the Unit, Wheels, Paint	Fair

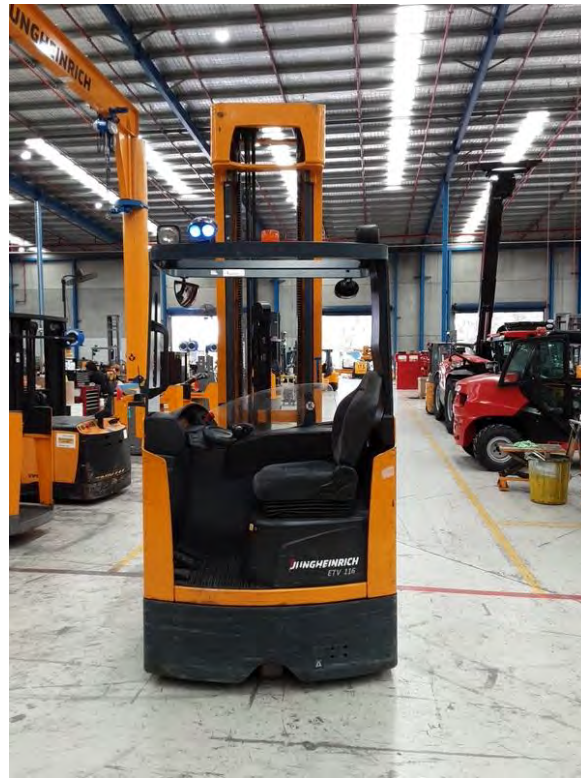
Photo 1

UNIT IN FAIR CONDITION NEEDS CLEAN AND PAINT TOUCH UP

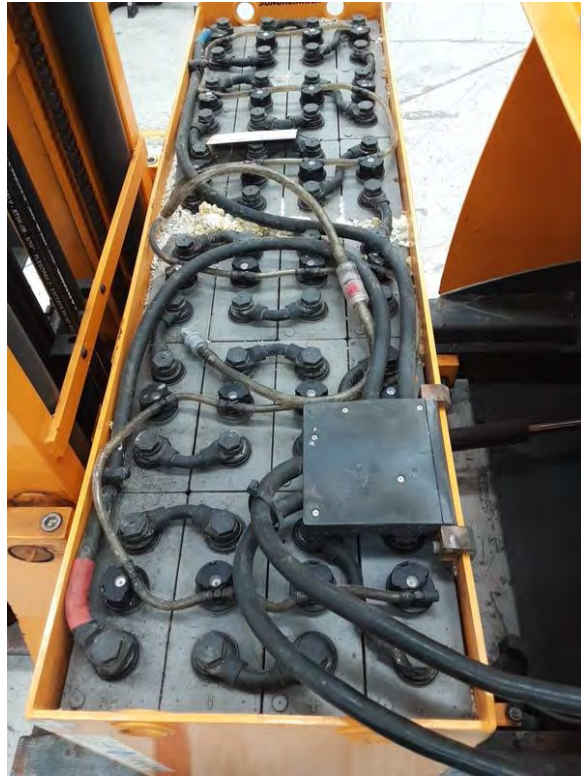
Photo 5

Battery has corrosion over the top of it

Battery covered in corrosion and water level is low

(Internal) Est. Labour Requirements to repair (hrs) 3 hr

Maybe longer depends how deep the corrosion goes
