MOTOR BOAT PRE PURCHASE

CLIENT'S NAME:	
DATE OF INSPECTION:	08/04/2020
SITE:	Sandbrook Inlet Marina, NSW
VESSEL DESIGN:	Halvorsen 25, Launched 1949
REGO NO:	NA990N
HIN:	AUWWA196185GV7
GENERAL DESCRIPTION:	Traditional timber cruiser
CONSTRUCTION:	Traditional carvel planked timber

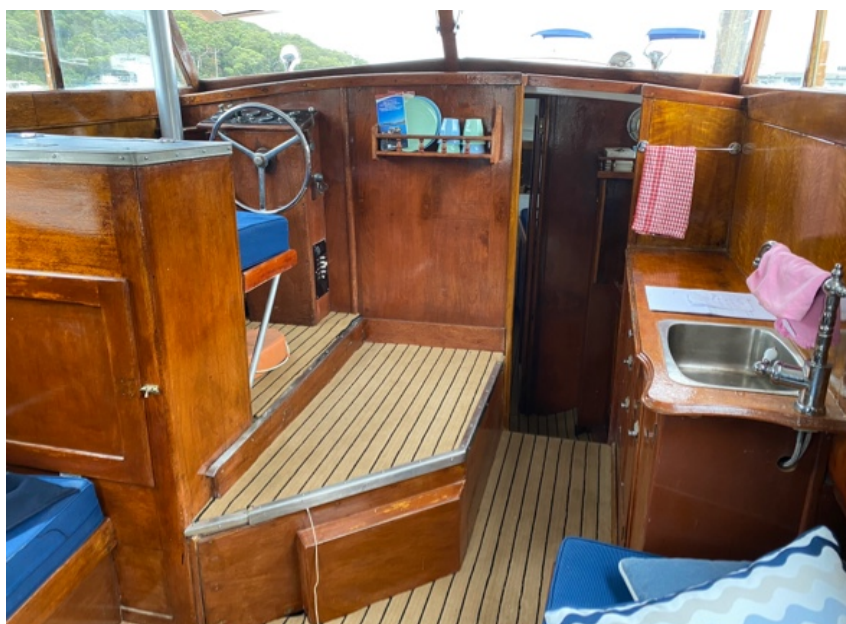
SEATING:	Good condition
DOORS:	Operational
CATCHES:	Operational
FLOOR BOARDS:	Wear and tear expected
TIMBER TRIMS ETC:	Good condition
