# Boat State & First Mate

Reference: RB648

Type of Survey: Insurance - Out of water survey

### **That's Amore – Gobbi 335 SC.**

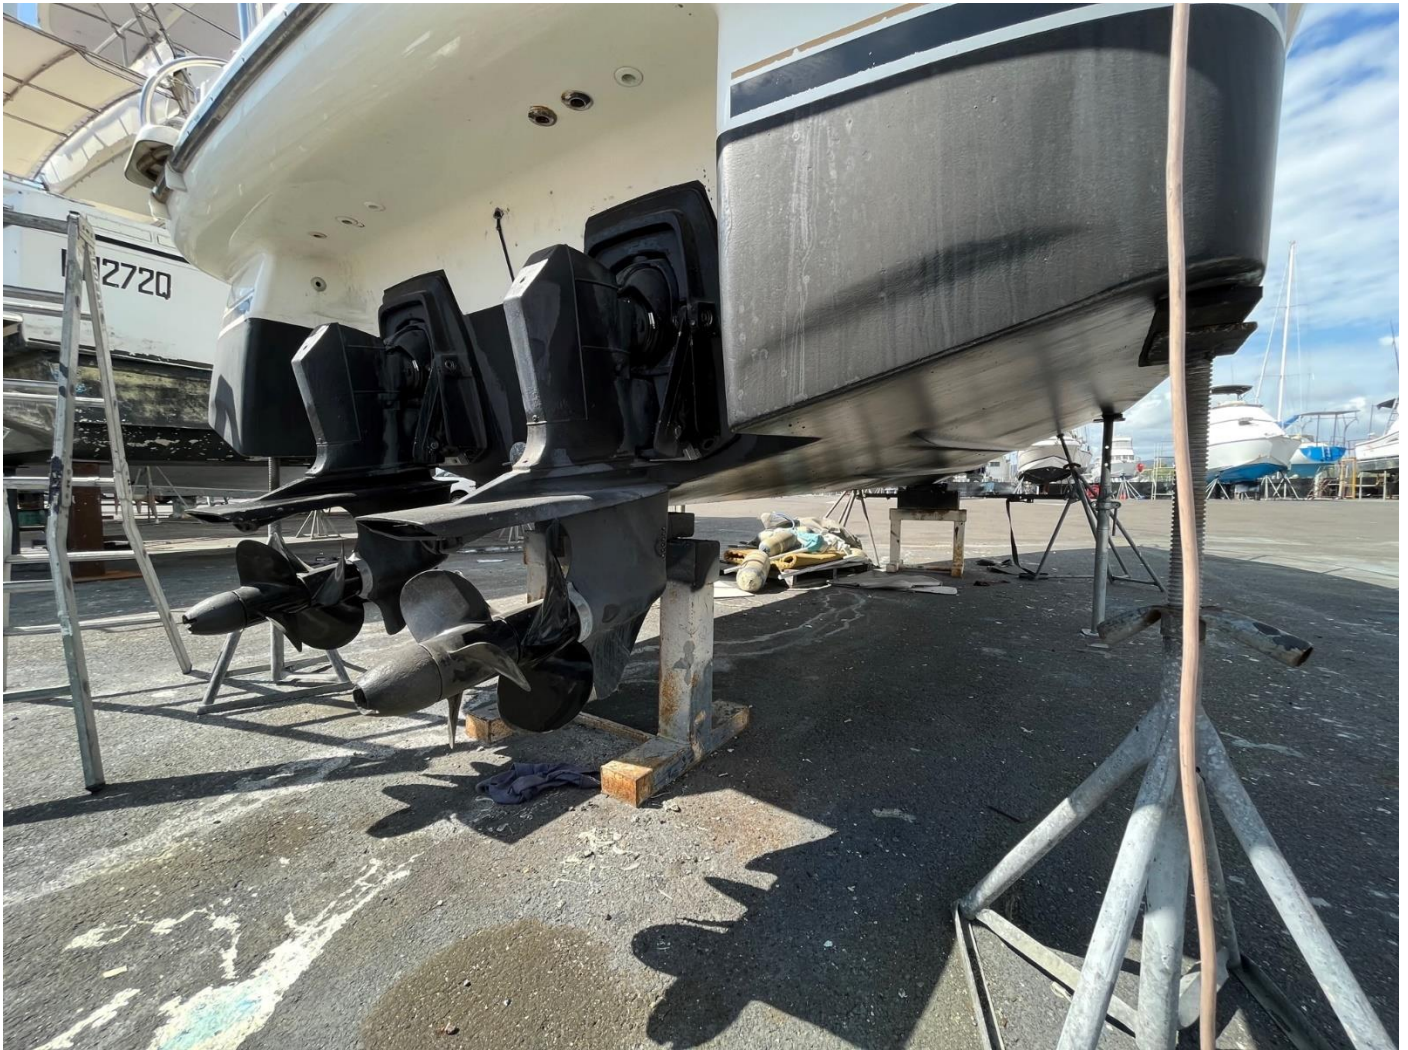
## Hull Overview Picture/s:

That's Amore is a fibreglass semi planning hull powered by stern drive twin Volvo Penta engines. Antifoul was reapplied on the 06/2022 and new anodes were also put on the vessel.

Condition	Comments
Gelcoat:	Satisfactory	The hull gelcoat presents in satisfactory condition with it been sitting in the sun and not maintained regularly in the last few months. The hull requires a good buff and detail to bring it back to a good standard.  There is a couple of crazing marks on the hull sides. (See picture 1 on page 8).  No other defects found.
Pinstriping:	Satisfactory	Pinstripe painting above the waterline is chipping away in sections all around the boat. (See picture 2 on page 8).
Under Water Surfaces:	Good	No damage or scrapes to hull. No abnormal moisture readings were detected, Hull was tap tested in multiple positions and there were no sign of osmosis, delamination, or any other defects in this hull.
Antifoul:	Excellent	New antifoul was applied on 06/2022. Hull was sanded and prepared correctly before antifouling. Antifoul was applied evenly with no thin spots.
Underwater Skin Fittings & Sea Strainers:	Satisfactory	All skin fittings and strainers below the water line are structurally in good condition, well-sealed, tight and no signs of leaking water. No blockages were found in the strainers or skin fittings.

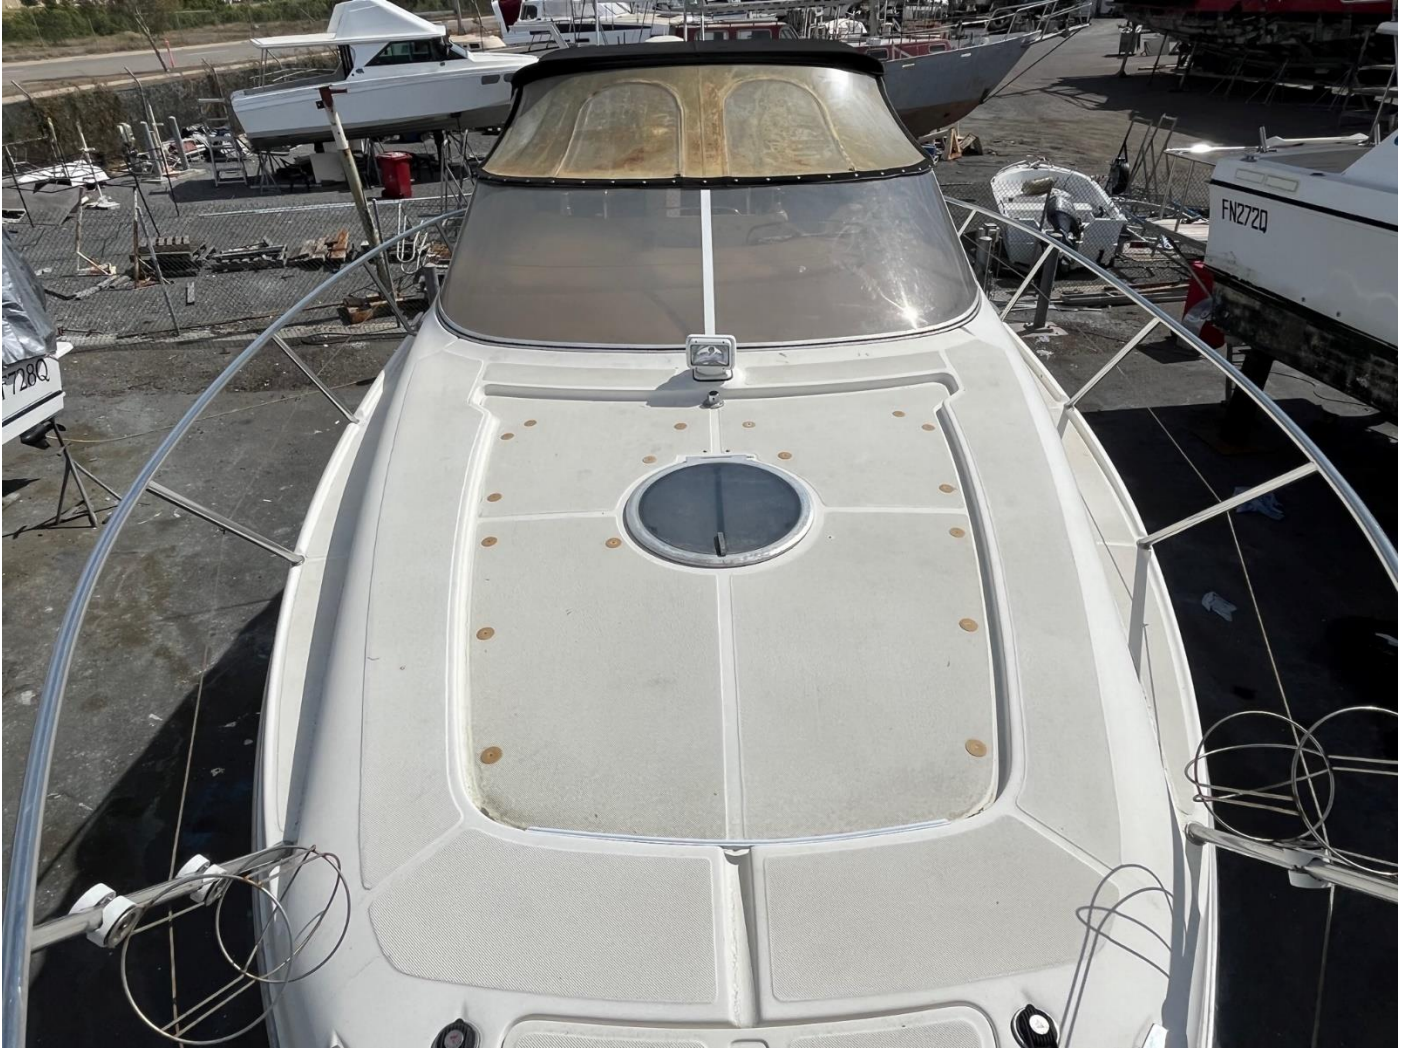
## Fore Deck / Side Deck & Hard Top Overview Picture/s:

Large foredeck with walk around side decks. Non-skid imprinted in gelcoat. Deck includes an electric anchor winch inside of the anchor locker, large wrap around stainless steel bow rail, anchor locker with large entry hatch, 1 x deck hatch and a spotlight.

Condition	Comments
Gelcoat & Non-Skid Surfaces:	Satisfactory	All gelcoat and non-skid surfaces are in good condition especially for the age of this vessel. The surfaces do require a good pressure clean and detail to make it look new again however the potential is there.
Anchor Roller Plates:	Satisfactory	The anchor roller plate is well sealed and tightly secured to the deck. There are a couple of rub / scuff marks on the plate as expected from the anchor and chain but are not causing any structural damage to the plate or surrounding areas. No defects found. 1 x plough anchor is in Satisfactory condition with no defects found.
Anchor Winch:	Satisfactory	Quick anchor winch was tested and in good working condition. The anchor chain is not rusted, and winch was fully operational. Anchor chain was secured to bulkhead in anchor locker. Total of 30 meters of chain in vessel.
Bow Rail:	Satisfactory	<p>The stainless-steel bow rail runs 3/4 way down both sides of the vessel. The steel is well maintained and not damaged in any way.</p> <p>The first feet on both sides of the bow rail and the last foot is little loose and lifted from the deck slightly. (See picture 3 on page 11).</p> <p>Some crazing and cracks are forming under some bow rail feet. (See picture 4 on page 11).</p>

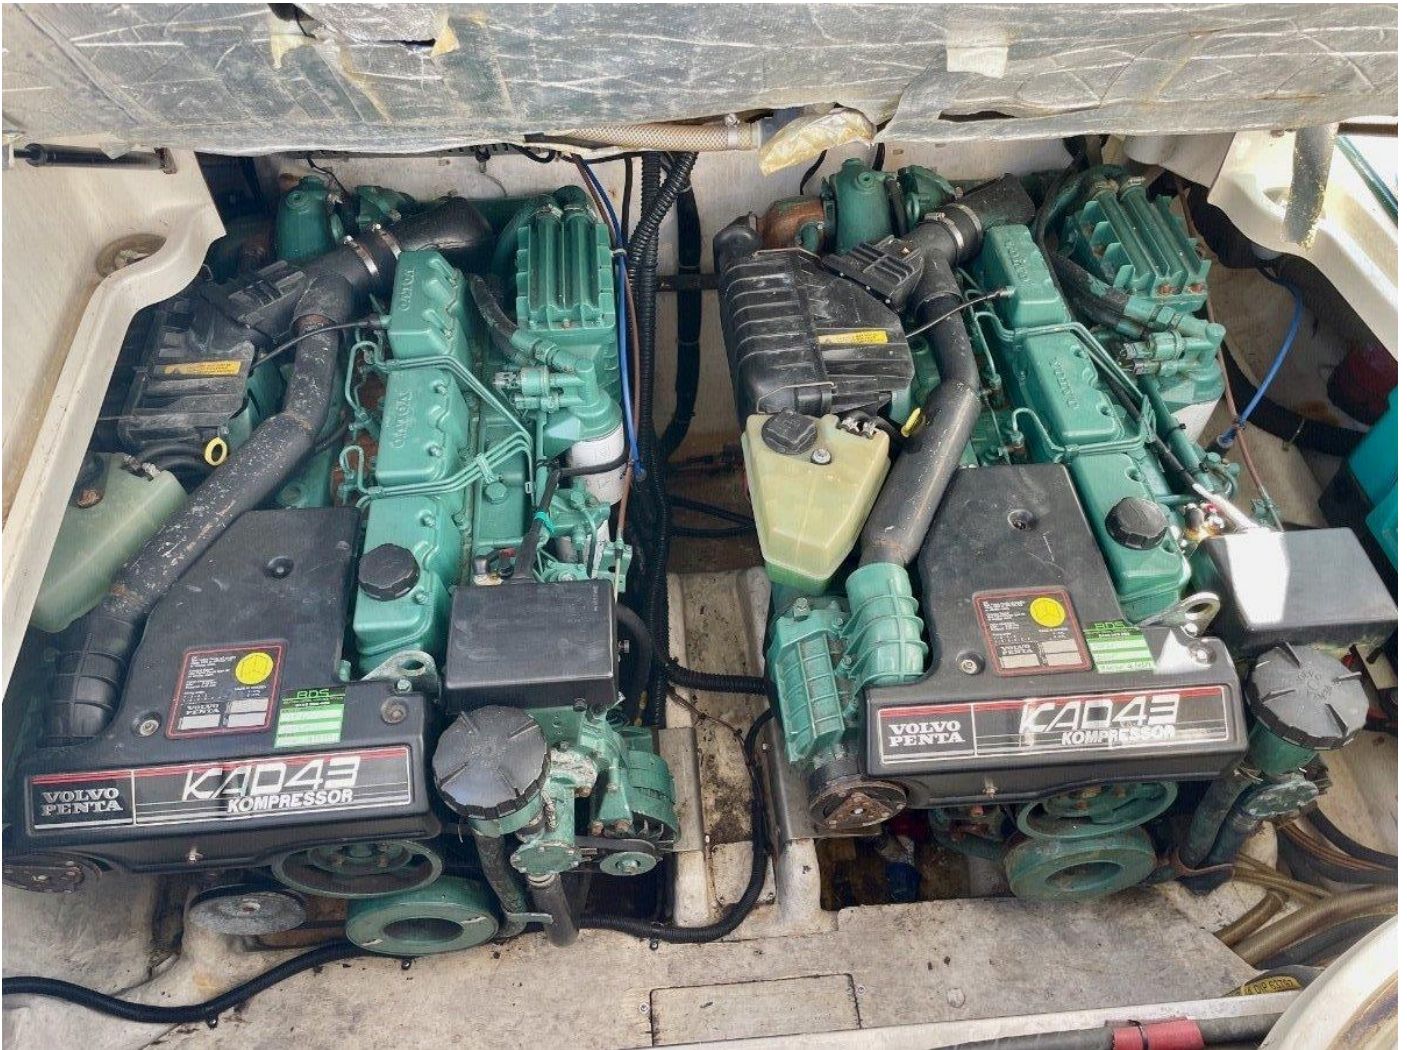
The Engine Room is accessed from the access hatch situated in the cockpit. The Engine Room houses 2 x Volvo Penta engines and associated systems.

Engine oils:	Satisfactory	Engine oils were checked and in good condition. Recently serviced. No burnt oil. No water in oil. Filters in good condition and recently replaced. Small drop of oil under both engines. Mechanic was aware of it and was investigating it further.
Transmissions:	Satisfactory	Oils, temperatures and pressures all good, clean, and recently serviced. No defects found.
Fuel Systems:	Satisfactory	All fuel filters were checked and in good condition. Recently serviced. No water in fuel filters. No signs of fuel leaks. Fuel gauges all working correctly. No defects found.
Bulkheads:	Good	All bulkheads, frames, stringers, and structural components of the vessel were in good condition with no cracks, damage, delamination, soft spot, or defects found.

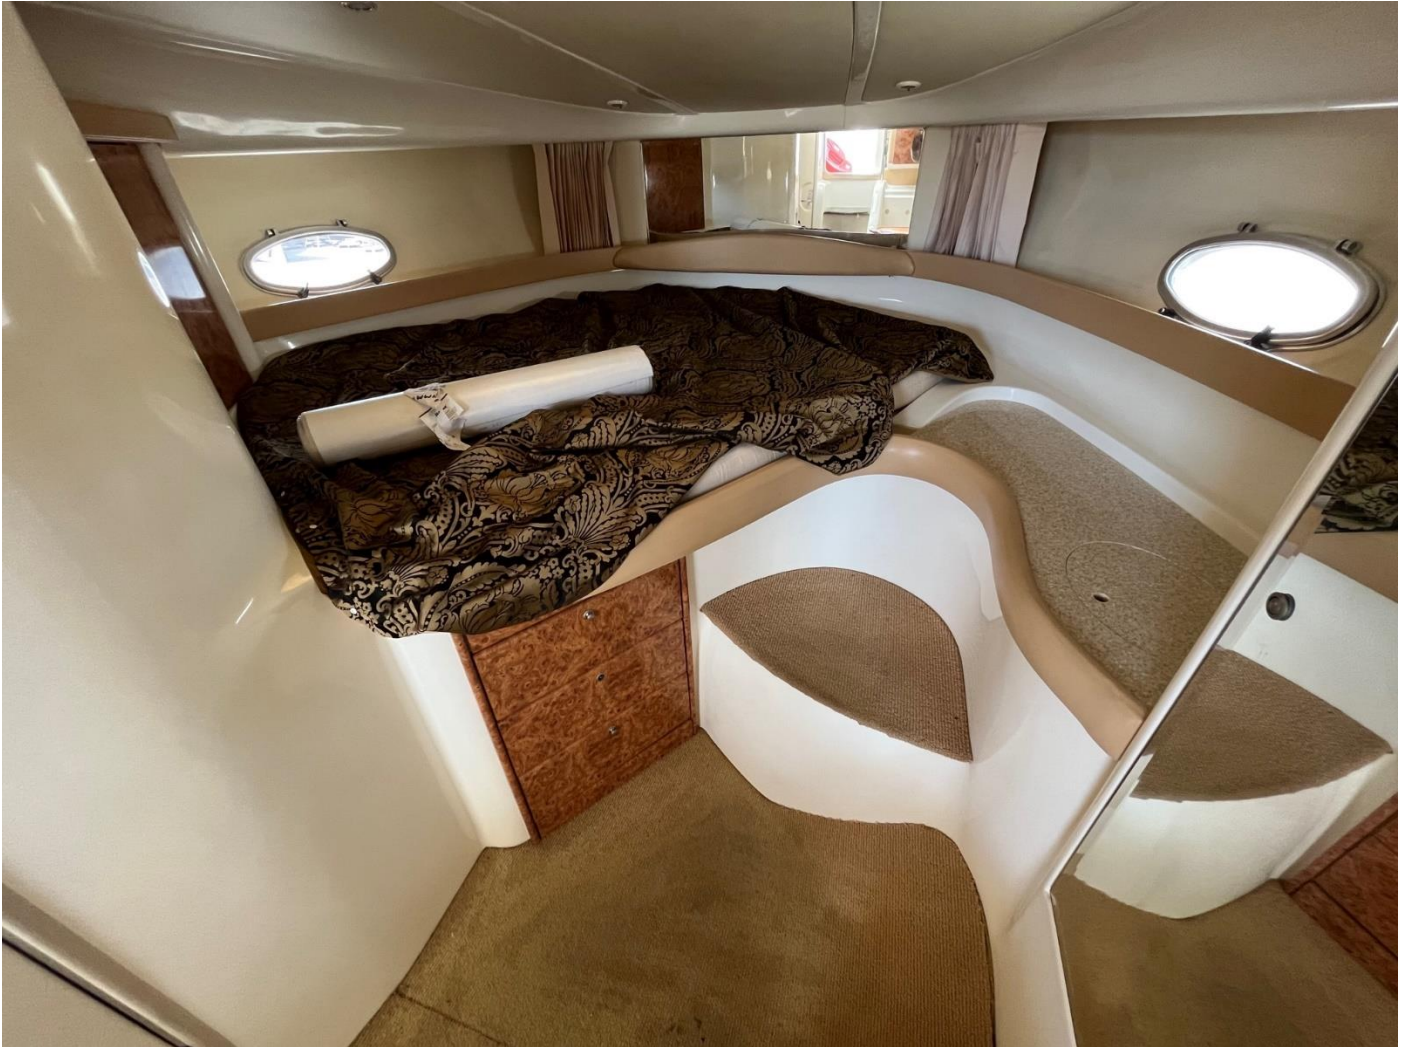
Stairs lead down from the helm station down to the hallway and fwd cabin. The fwd cabin houses a double bed with draws underneath as well as a large storage area beneath the bed.

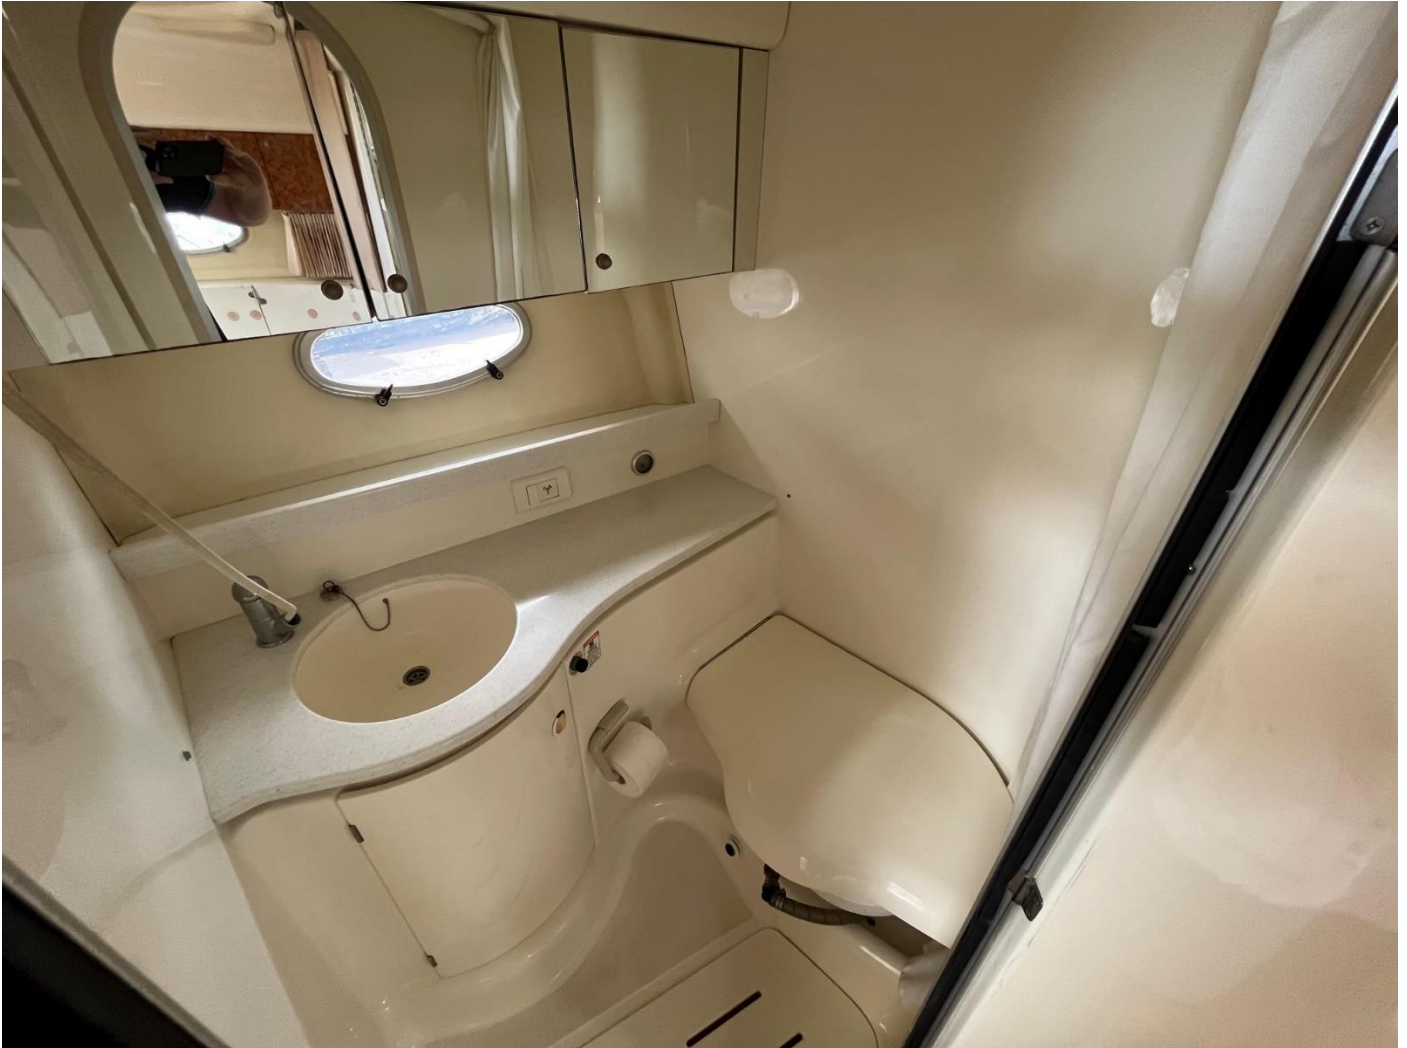
## Bathroom Overview Picture:

The Bathroom is situated on the port side of the vessel just behind the fwd cabin. The bathroom has a toilet, sink, shower that shares the tap from the basin and a port window for air and lighting.

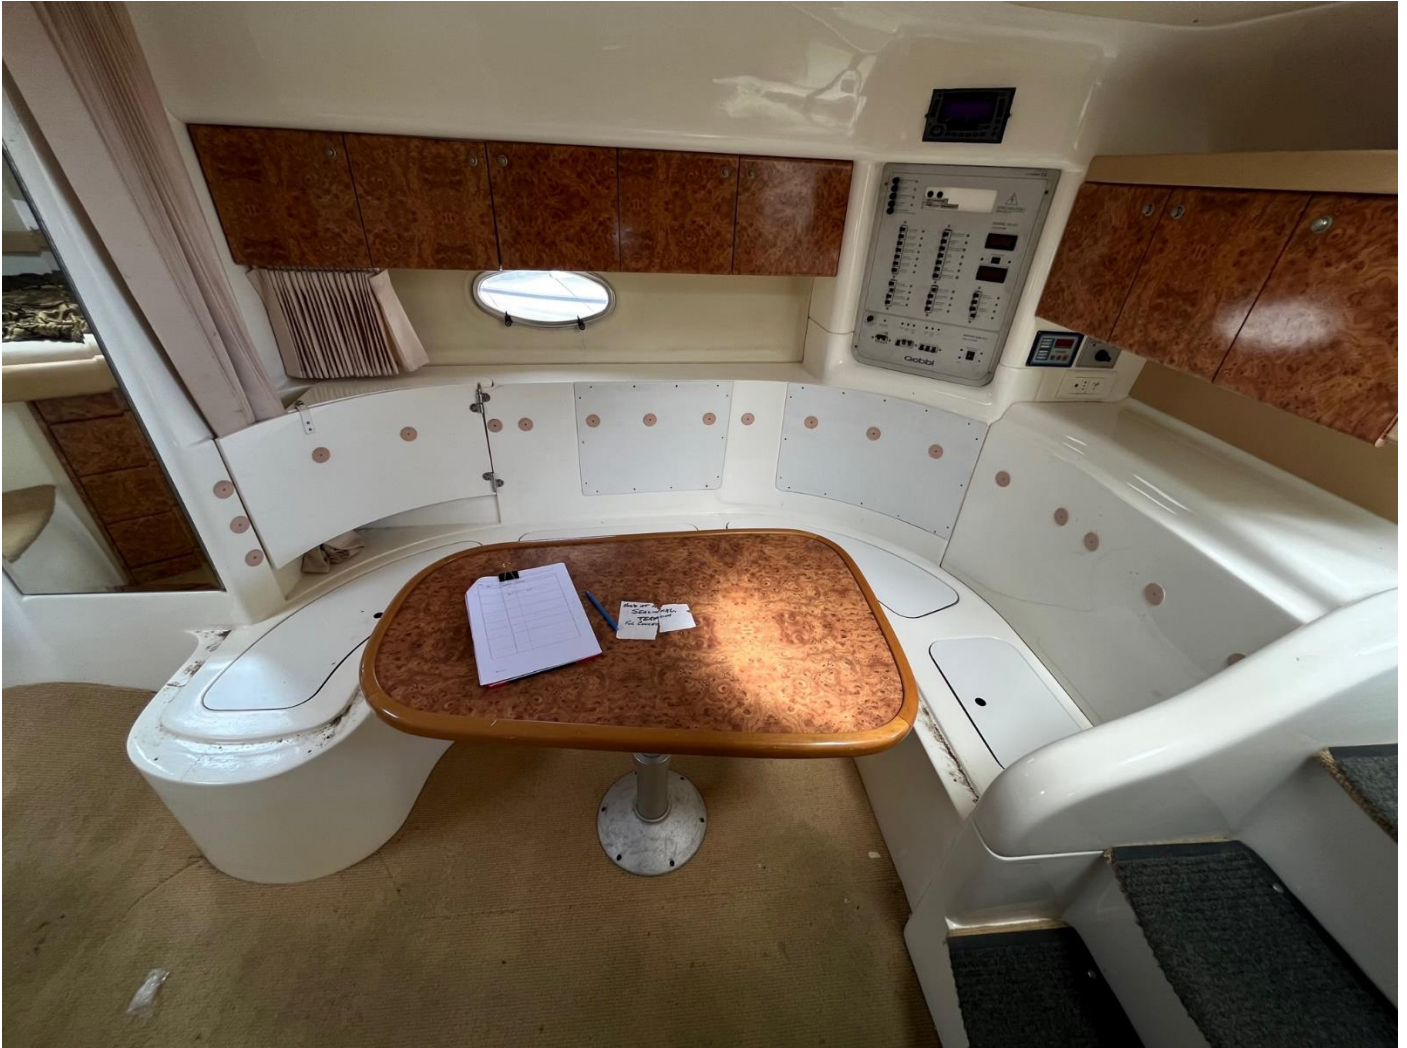
## Saloon Overview Picture/s:

The Saloon is situated on the stbd side of the vessel as you walk down the stairs from the helm station. Large U shape lounge with storage underneath, dining table, switch panel and a VHF on the rear wall.

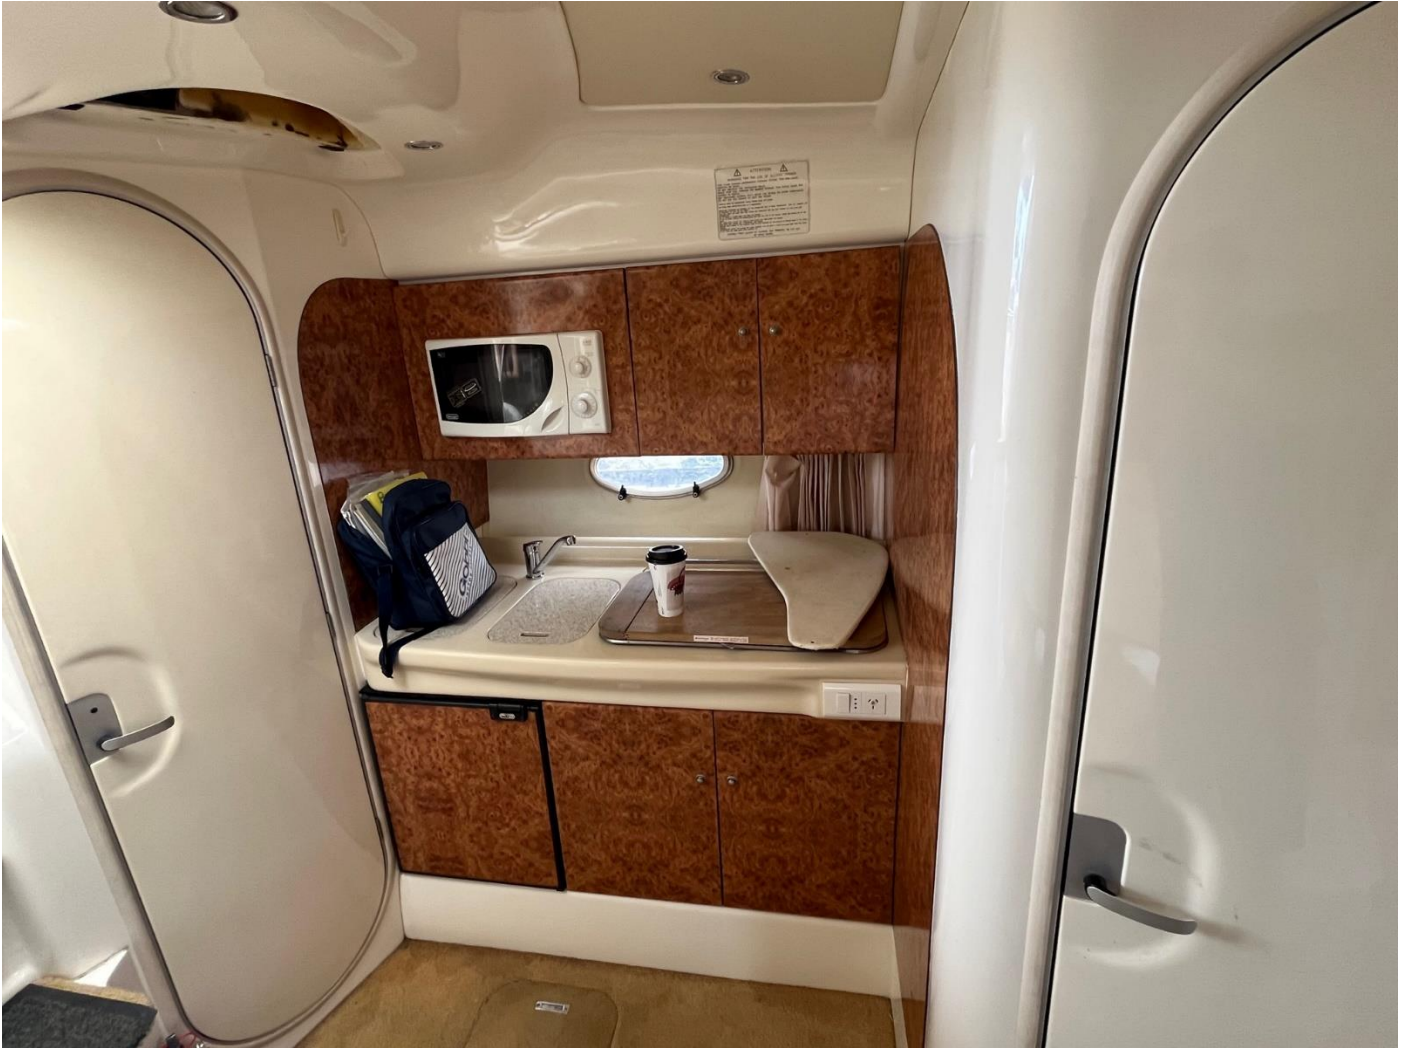
## Galley Overview Picture/s:

The galley is situated on the port side of the vessel opposite the saloon area. The Galley includes a fridge, microwave, sink and tap and cupboard areas.

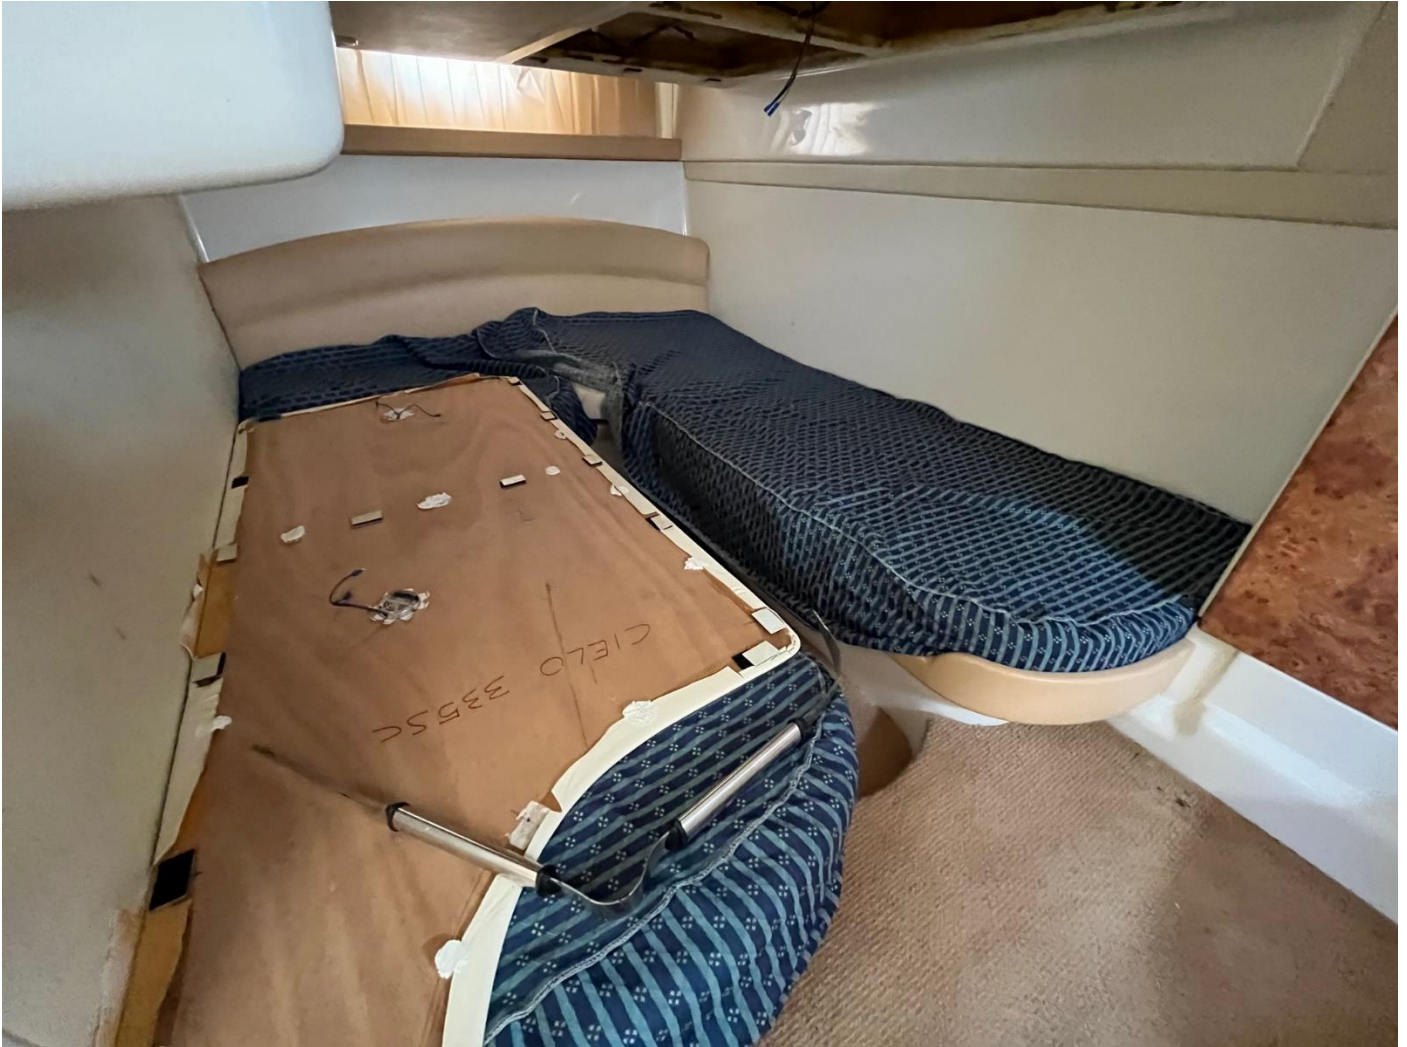
The Aft Cabin is situated to the rear of the vessel and is entered through the door to the aft end of the galley. It includes 2 x single beds, both with storage underneath, a hanging locker and bench as well as a porthole for light and fresh air.
