SLIPSTREAM
MARINE
BOAT SURVEYING

MOTOR BOAT PRE PURCHASE

CLIENT'S NAME:	
DATE OF INSPECTION:	16 July 2024
SITE:	Kirribilli and Noakes Boatyard, NSW
VESSEL DESIGN:	1989 Ranger 47 - 1E 20 PAX - 2 Crew. Expires 14/09/2028
REGO NO:	AMSA UVI: 422962 & 18246 (Displayed)
HIN:	Not required for commercial vessels
GENERAL DESCRIPTION:	Flybridge Cruiser
CONSTRUCTION:	Composite GRP with Timber Fitout

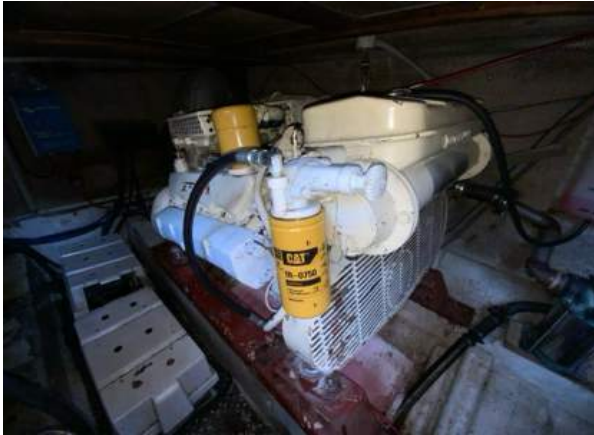
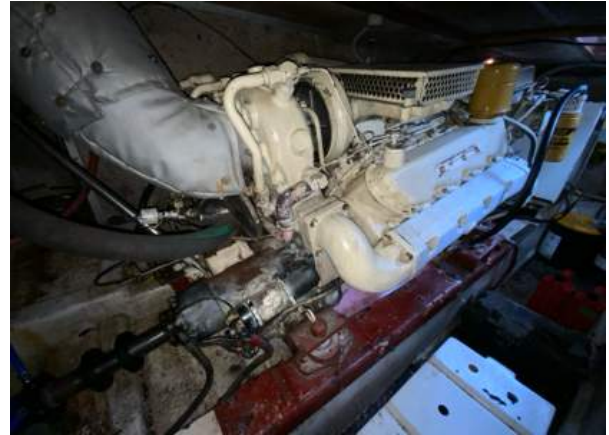
MECHANICAL: PORT ENGINE

MAKE AND MODEL:	Caterpillar 3208 - 375 hp @ 2300 RPM
SERIAL NO:	01Z16573
HRS:	8262 on guages

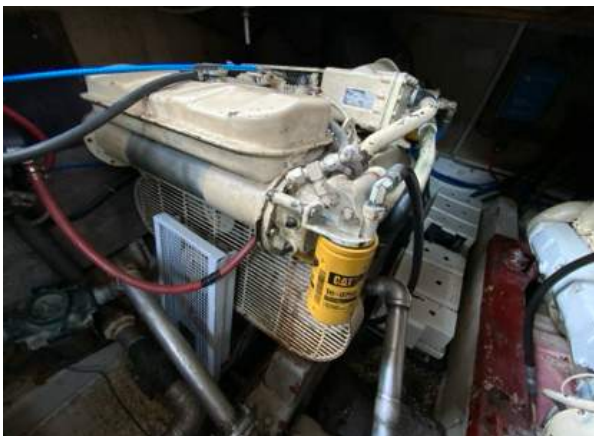
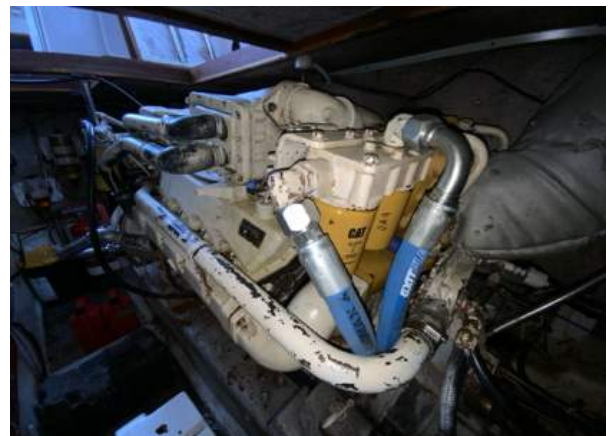
MECHANICAL: STB ENGINE

MAKE AND MODEL:	Caterpillar 3208 - 375 hp @ 2300 RPM
SERIAL NO:	01Z16564
HRS:	7182 on guages

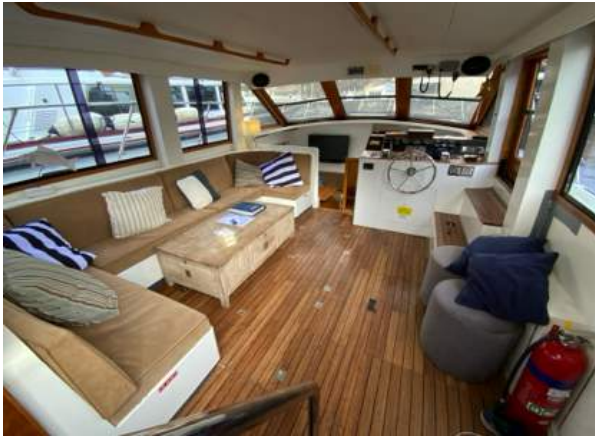
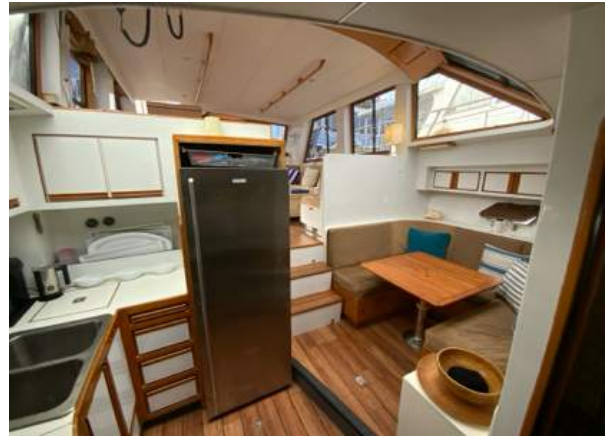
FIT OUT AND FURNISHINGS:

SEATING:	Acceptable with general wear and tear
----------	---------------------------------------

HEAD LINER:	Acceptable with general wear and tear
HULL LINING:	Acceptable with general wear and tear
DOORS:	Various adjustments required
CATCHES:	Various adjustments required
FLOOR BOARDS:	General wear and tear

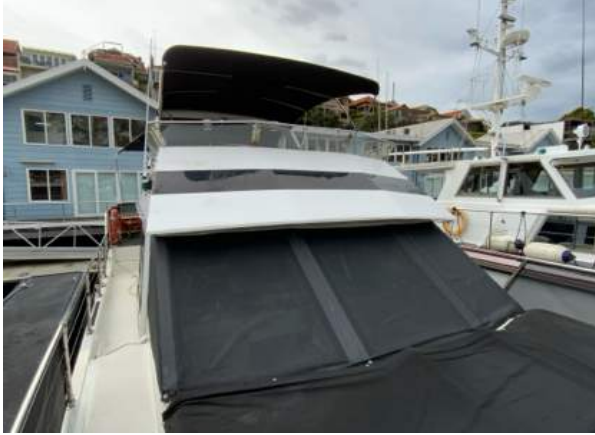
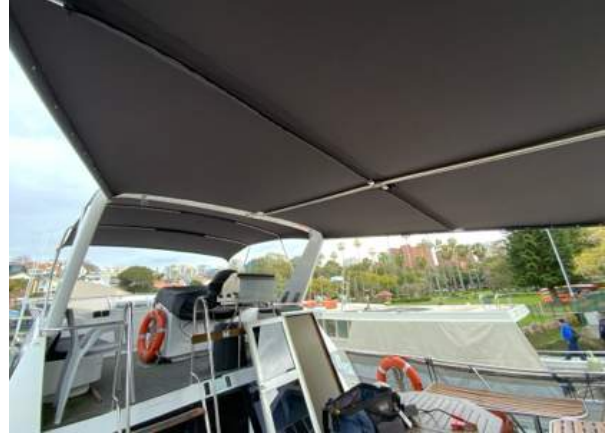
COVERS AND CLEARS

COCKPIT:	Skirts: Acceptable with general wear and tear
AWNING:	Acceptable with general wear and tear
BIMINI:	Acceptable with general wear and tear
SCREEN COVERS	Acceptable with general wear and tear
HELM COVERS	Acceptable with general wear and tear
SEAT COVERS	Acceptable with general wear and tear

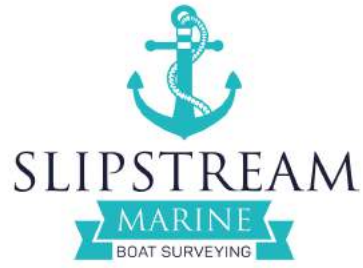
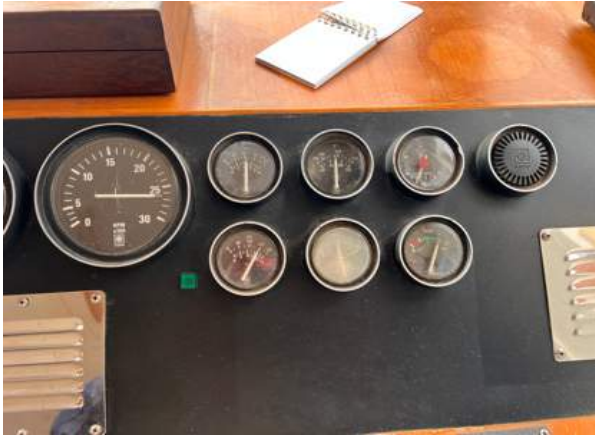
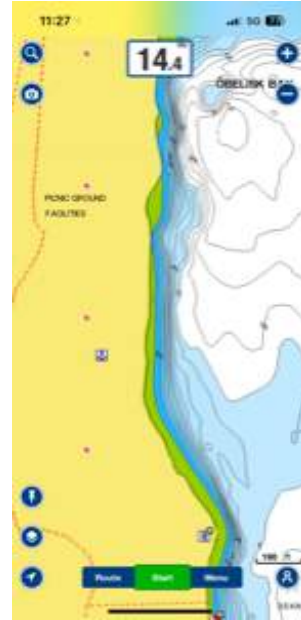
SEA TRIAL

WEATHER	Overcast
WIND	12 knots SW
TIDE	1.0m and falling
IDLE RPM	Approximately 600 RPM (guages out)
RPM @ WOT	Approximately 2300 RPM (guages out)
MAX TEMPERATURE	Port sender out, staboard 88 degrees and slight climbing
IDLE SPEED	4 knots
MAXIMUM SPEED	15 knots
TRIM	Faulty
VIBRATION	Smooth
STEERAGE	Operational, rudder angle indicator out
