## HAZELWOOD MARINE Pty Ltd

Report Carried Out At: Jones Island Manning Valley NSW

Vessel: American built Trojan 4400 fibreglass sports cruiser.

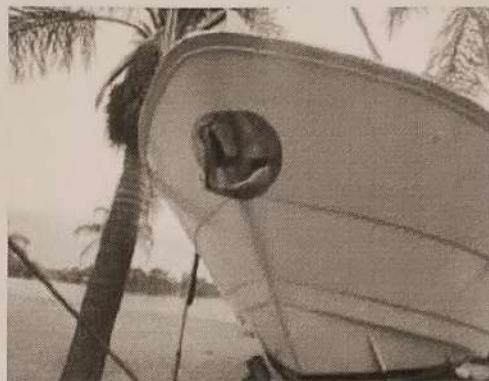
## HULL EXTERNAL 2.

2.1	A	Topsides	Original gelcoat in fair condition. • There is some minor cosmetic damage on the starboard side from docking.
2.2	A	Underwater	There is no evidence of grounding or collision below the waterline
2.3	NA	Docking Strip	
2.4	A	Sponsons	Alloy moulding at gunwale level
2.5	A	Anodes	The anodes are being replaced at this slipping.
2.6	NA	Bonding	
2.7	A	Hull Deck Join	Glassed
2.8	A	Trim Tabs	
2.9	A	Antifoul	The vessel is being antifouled at this time.
2.10	A	Keel

Generally, the vessel is sound and there is no evidence of grounding or collision below the waterline. All service inspected on board appeared to be in good condition with plumbing and electrical services well secured.

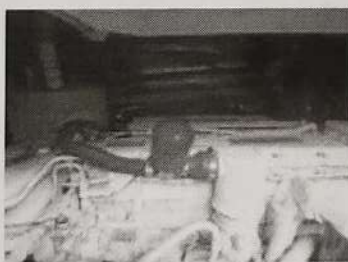
#### ELECTRICAL INSTALLATION 5.

5.1	A	Type 12 volt DC	This service has its own dedicated circuit breakers.
5.2	A	Type 110V/240 volt AC	This service has its own circuit breakers.
5.3	A	Lights Cabin	
5.4	A	Lights Nav
