SLIPSTREAM
MARINE
BOAT SURVEYING

MOTOR BOAT INSURANCE

CLIENT'S NAME:	Bruce Porter
DATE OF INSPECTION:	12 March 2024
SITE:	Shell Point Marina, Taren Point NSW
VESSEL DESIGN:	58 Custom Steel Flybridge Cruiser, Launched 1976.
REGO NO:	FY804N
HIN:	Not fitted
GENERAL DESCRIPTION:	Flybridge Cruiser
CONSTRUCTION:	Steel, replated below waterline approximately 12 years previous

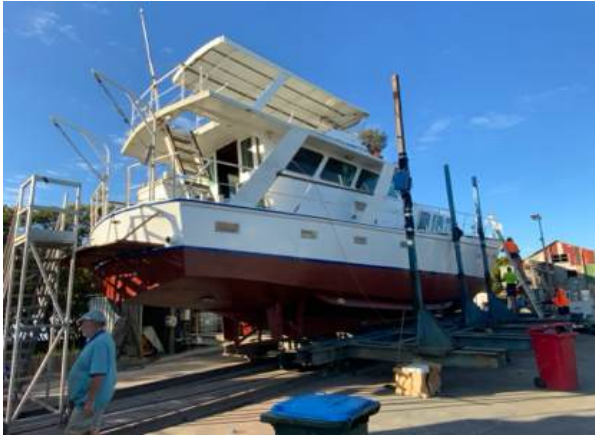
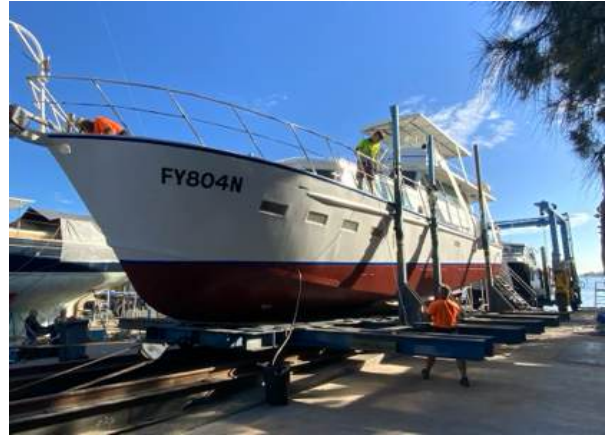
TOPSIDES:	<input checked="" type="checkbox"/>	<input type="checkbox"/>	Structurally sound and repainted at inspection
BOOT STRIPE AND GUNNEL BAND:	<input checked="" type="checkbox"/>	<input type="checkbox"/>	Repainted at inspection
BOTTOMS:	<input checked="" type="checkbox"/>	<input type="checkbox"/>	Structurally sound and in good condition
ANTIFOULING:	<input checked="" type="checkbox"/>	<input type="checkbox"/>	New coatings applied at inspection
HULL AND DECK JOIN:	<input checked="" type="checkbox"/>	<input type="checkbox"/>	Structurally sound and secured
KEEL AND FIXINGS:	<input checked="" type="checkbox"/>	<input type="checkbox"/>	Main keel and bilge keels sound and secured
RUBBING STRIP:	<input checked="" type="checkbox"/>	<input type="checkbox"/>	Structurally sound
BULKHEADS AND BONDINGS:	<input checked="" type="checkbox"/>	<input type="checkbox"/>	Structurally sound and coatings good
PORTS AND WINDOWS:	<input checked="" type="checkbox"/>	<input type="checkbox"/>	Secured and undamaged

BOARDING OR SWIM PLATFORM	<input checked="" type="checkbox"/>	<input type="checkbox"/>	Secured with general wear and tear
ENGINE BEDS	<input checked="" type="checkbox"/>	<input type="checkbox"/>	Structurally sound and coatings good
STRINGERS	<input checked="" type="checkbox"/>	<input type="checkbox"/>	Structurally sound and coatings good
CHINES	<input checked="" type="checkbox"/>	<input type="checkbox"/>	Structurally sound and coatings good
BOARDING PLATFORM SUPPORT	<input checked="" type="checkbox"/>	<input type="checkbox"/>	Secured and undamaged
TRANSOM	<input checked="" type="checkbox"/>	<input type="checkbox"/>	Structurally sound and coatings good
STEM	<input checked="" type="checkbox"/>	<input type="checkbox"/>	Structurally sound and coatings good

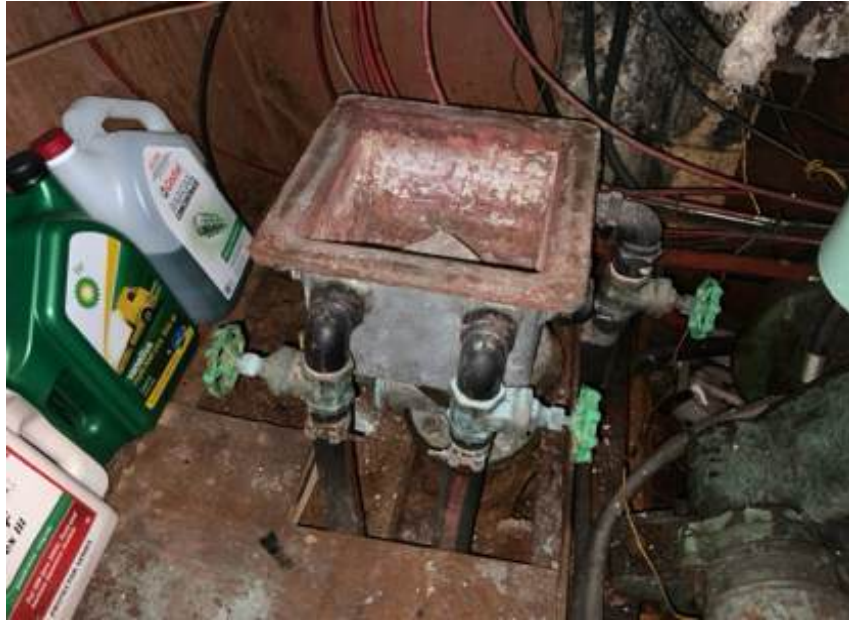
SEACOCKS AND THROUGH HULL FITTINGS:

THROUGH HULL TRANSDUCERS:	<input checked="" type="checkbox"/>	<input type="checkbox"/>	Secured and operational
ENGINE INTAKE:	<input checked="" type="checkbox"/>	<input type="checkbox"/>	Main seachest serviced at inspection and tested operational
EXHAUST OUTLET:	<input checked="" type="checkbox"/>	<input type="checkbox"/>	Secured and operational
DECK WASH INTAKE	<input checked="" type="checkbox"/>	<input type="checkbox"/>	Secured and operational
GENERATOR INTAKE	<input checked="" type="checkbox"/>	<input type="checkbox"/>	Secured and operational
GENERATOR EXHAUST	<input checked="" type="checkbox"/>	<input type="checkbox"/>	Secured and operational

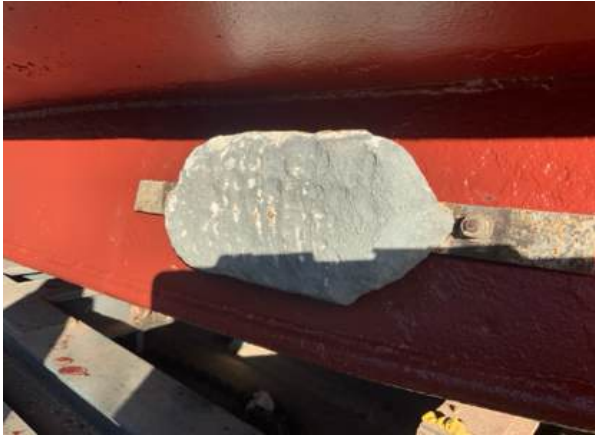
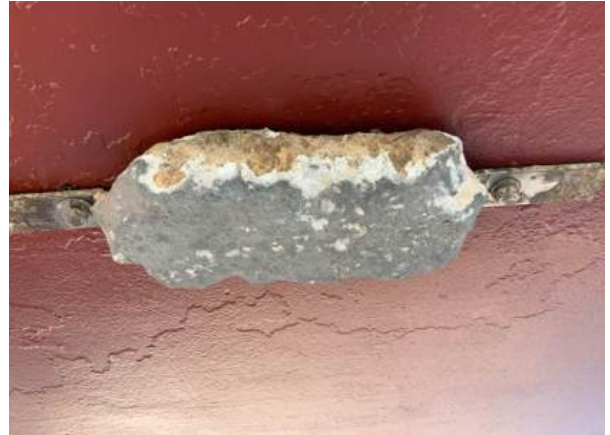
CATHODIC PROTECTION

HULL ANODES:	<input checked="" type="checkbox"/>	<input type="checkbox"/>	All units at 80%
SHAFT ANODES:	<input checked="" type="checkbox"/>	<input type="checkbox"/>	All units at 80%

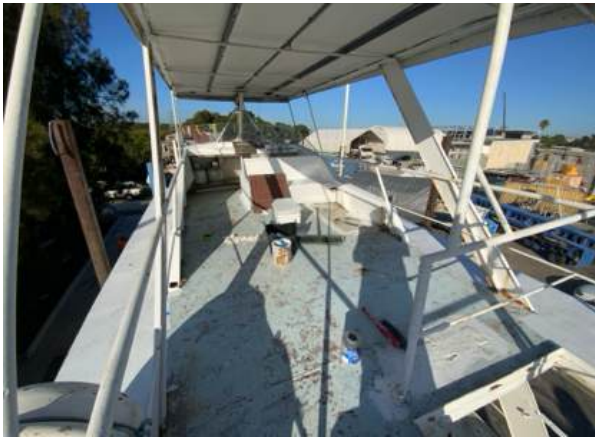
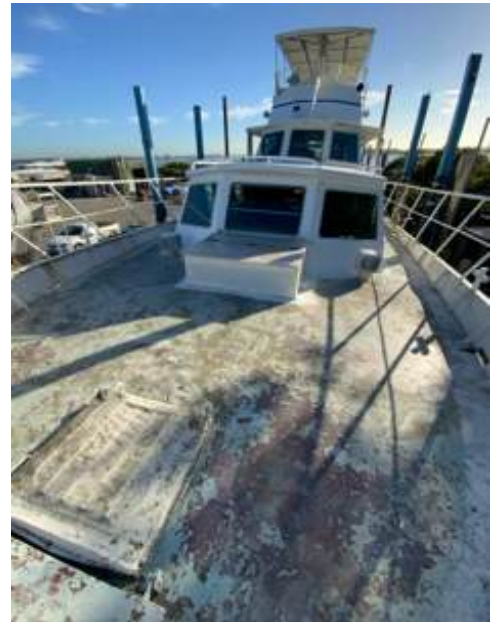
DECK AND TOP MOLDINGS

CABIN SIDES:	<input checked="" type="checkbox"/> <input type="checkbox"/>	Structurally sound with general wear and tear, new paint coatings at inspection
CABIN TOP:	<input checked="" type="checkbox"/> <input type="checkbox"/>	Structurally sound with general wear and tear, new paint coatings at inspection
DECK DEAMS:	<input checked="" type="checkbox"/> <input type="checkbox"/>	Structurally sound with general wear and tear
DECK STRUCTURE:	<input checked="" type="checkbox"/> <input type="checkbox"/>	Structurally sound and preped for new non skid coatings
FLYBRIDGE STRUCTURE:	<input checked="" type="checkbox"/> <input type="checkbox"/>	Structurally sound with new coatings Minor corrosion noted wings support connections at main deck
BOW RAIL:	<input checked="" type="checkbox"/> <input type="checkbox"/>	Secured and undamaged
BULWARKS:	<input checked="" type="checkbox"/> <input type="checkbox"/>	Structurally sound with new paint coatings

GRAB RAILS:	<input checked="" type="checkbox"/> <input type="checkbox"/>	Secured with new paint coatings being applied
HATCHES AND PORTS:	<input checked="" type="checkbox"/> <input type="checkbox"/>	Secured and weathertight
WINDOWS AND SCREENS:	<input checked="" type="checkbox"/> <input type="checkbox"/>	Secured and weathertight
ANCHOR WINCH MOUNTINGS:	<input checked="" type="checkbox"/> <input type="checkbox"/>	Structurally sound with minor surface corrosion being treated
ANCHOR:	<input checked="" type="checkbox"/> <input type="checkbox"/>	Acceptable with general wear and tear

ANCHOR CHAIN AND WARP:	<input checked="" type="checkbox"/> <input type="checkbox"/>	Acceptable with general wear and tear
BOW FITTINGS AND ROLLERS:	<input checked="" type="checkbox"/> <input type="checkbox"/>	Acceptable with general wear and tear
CLEATS:	<input checked="" type="checkbox"/> <input type="checkbox"/>	Acceptable with general wear and tear
COMPANIONWAY DOORS	<input checked="" type="checkbox"/> <input type="checkbox"/>	Secured and weathertight

1. Update onboard fire fighting appliances
2. Recertification of gas system advisable
3. Make navigation lights function for night voyages
4. Finalise non skid applications on deck surfaces (prepped for application)

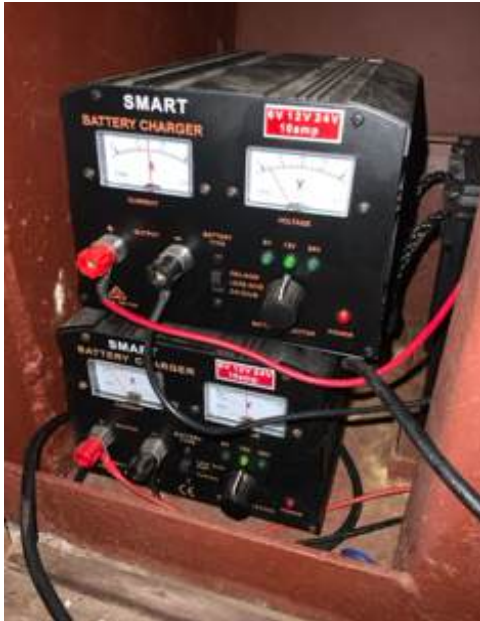
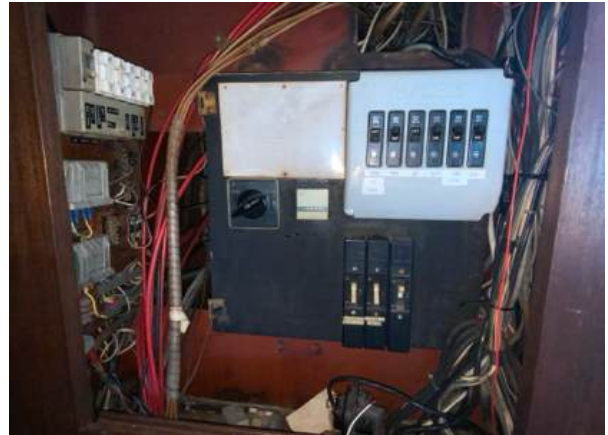
ELECTRICAL SYSTEM: 240V

POWER POINTS:	<input checked="" type="checkbox"/>	<input type="checkbox"/>	Tested operational
BATTERY CHARGER:	<input checked="" type="checkbox"/>	<input type="checkbox"/>	Tested operational
HOT WATER SYSTEM:	<input checked="" type="checkbox"/>	<input type="checkbox"/>	Tested operational
FRIDGE:	<input checked="" type="checkbox"/>	<input type="checkbox"/>	Tested operational
SHORE POWER LEAD:	<input checked="" type="checkbox"/>	<input type="checkbox"/>	Domestic type only

MICROWAVE:	<input checked="" type="checkbox"/> <input type="checkbox"/>	Tested operational
DISTRIBUTION PANEL:	<input checked="" type="checkbox"/> <input type="checkbox"/>	Breaker panel only

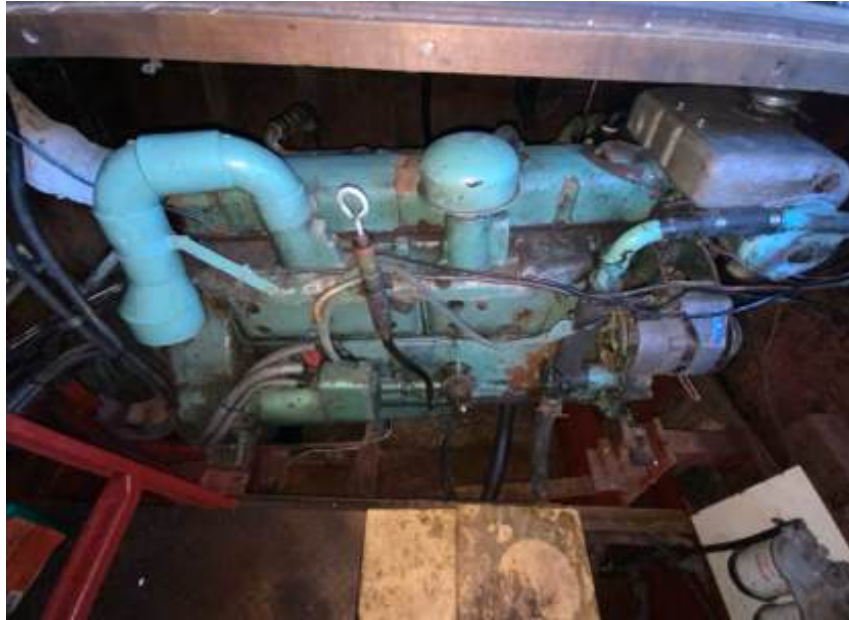
MECHANICAL: PORT ENGINE

MAKE AND MODEL:	<input checked="" type="checkbox"/> <input type="checkbox"/>	Bedford 500 Series - 160 hp
HRS:	<input checked="" type="checkbox"/> <input type="checkbox"/>	912 on guage at helm

OTHER:	Serviced at time of inspection
--------	--------------------------------

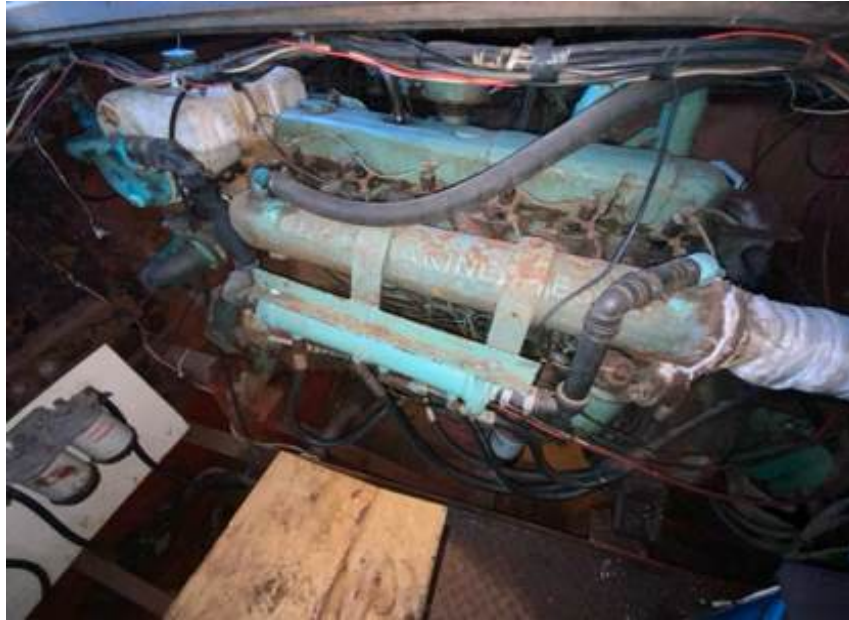
MECHANICAL: STB ENGINE

MAKE AND MODEL:	<input checked="" type="checkbox"/> <input type="checkbox"/> Bedford 500 Series - 160 hp
HRS:	<input checked="" type="checkbox"/> <input type="checkbox"/> 873 on guage

OTHER:	Serviced at time of inspection
--------	--------------------------------

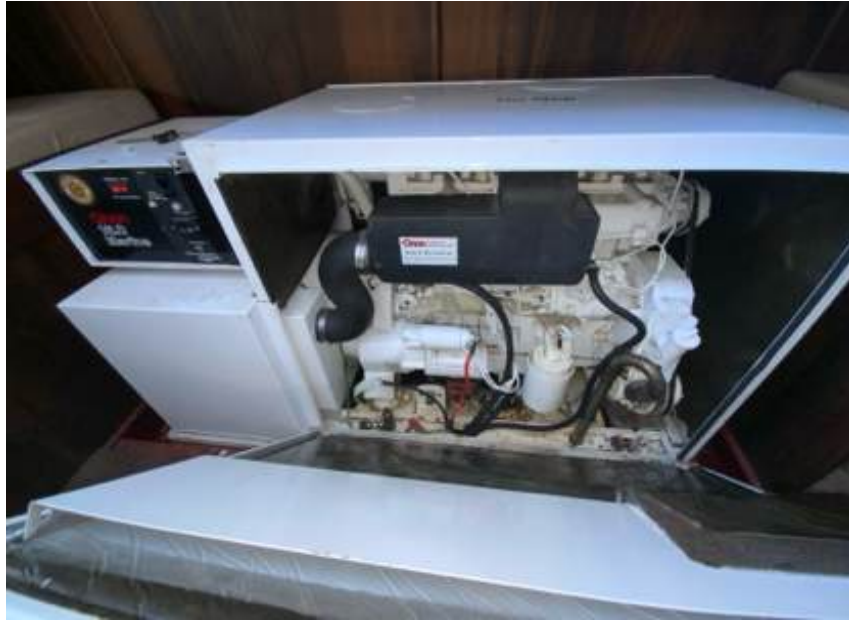
MECHANICAL: GENERATOR 1

MAKE AND MODEL:	<input checked="" type="checkbox"/> <input type="checkbox"/> Onan 16MDL4P- 16 kW @ 1500 RPM
SERIAL NO:	<input checked="" type="checkbox"/> <input type="checkbox"/> F943198467
HRS:	<input checked="" type="checkbox"/> <input type="checkbox"/> 472

OTHER:	Serviced at time of inspection
--------	--------------------------------

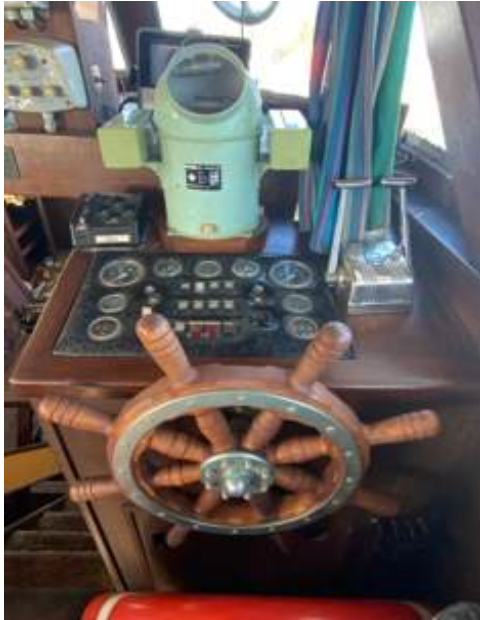
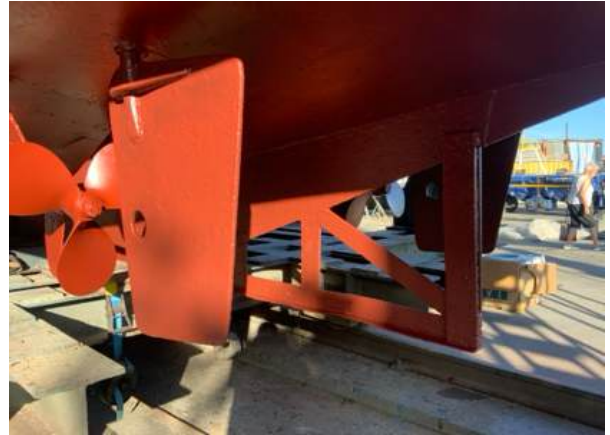
STEERING SYSTEM

HYDRAULIC RAM:	<input checked="" type="checkbox"/> <input type="checkbox"/>	Secured and operational
WHEEL:	<input checked="" type="checkbox"/> <input type="checkbox"/>	Secured and operational at both helms
RUDDERS:	<input checked="" type="checkbox"/> <input type="checkbox"/>	Structurally sound and in good condition
RUDDER GLANDS:	<input checked="" type="checkbox"/> <input type="checkbox"/>	Serviced at out of water period
COMPASS:	<input checked="" type="checkbox"/> <input type="checkbox"/>	Dated but appears accurate
HYDRAULIC LINES	<input checked="" type="checkbox"/> <input type="checkbox"/>	No leaks noted
RUDDER ANGLE INDICATOR	<input checked="" type="checkbox"/> <input type="checkbox"/>	Accurate

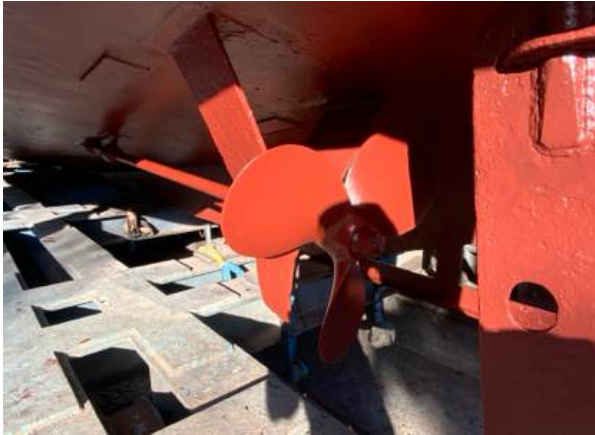
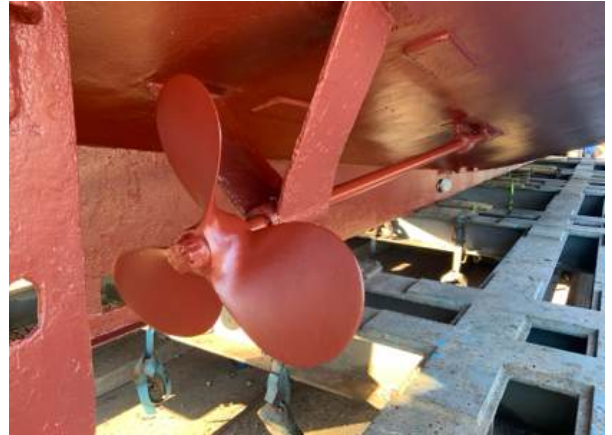
RUNNING GEAR

PROPELLORS:	<input checked="" type="checkbox"/>	<input type="checkbox"/>	New propellers fitted both port and starboard sides
PROPELLOR SHAFTS	<input checked="" type="checkbox"/>	<input type="checkbox"/>	Good condition
STERN GLANDS:	<input checked="" type="checkbox"/>	<input type="checkbox"/>	Serviced at out of water period
SKEG & BEARINGS:	<input checked="" type="checkbox"/>	<input type="checkbox"/>	Acceptable tolerances on all bearings
RUDDER BEARINGS:	<input checked="" type="checkbox"/>	<input type="checkbox"/>	Acceptable tolerances on all bearings

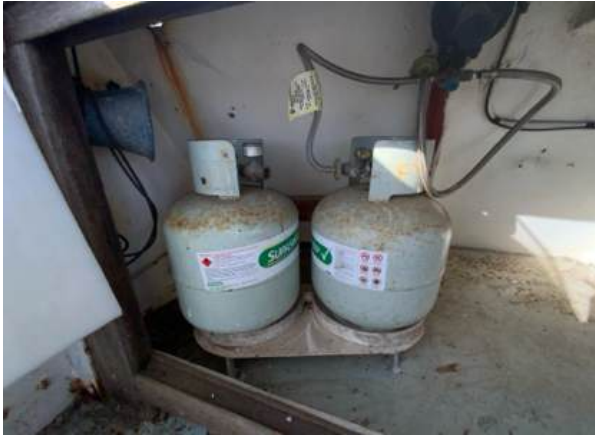
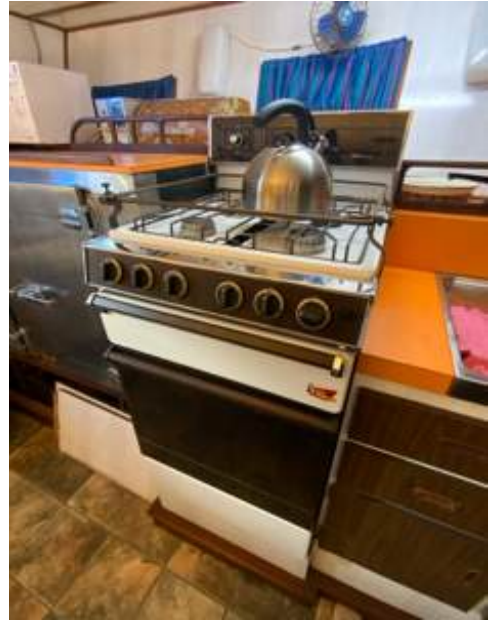
GAS INSTALLATION

COMPLIANT:	<input checked="" type="checkbox"/> <input type="checkbox"/>	Compliance plate 1986, updated inspection and certification advisable
STOVE:	<input checked="" type="checkbox"/> <input type="checkbox"/>	Good condition
OVEN:	<input checked="" type="checkbox"/> <input type="checkbox"/>	Good condition
REGULATOR:	<input checked="" type="checkbox"/> <input type="checkbox"/>	Single only

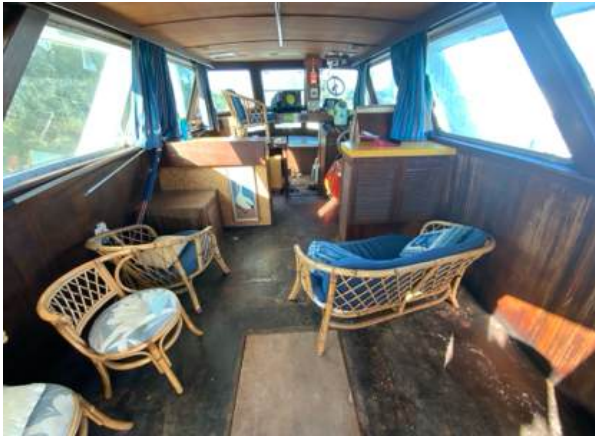
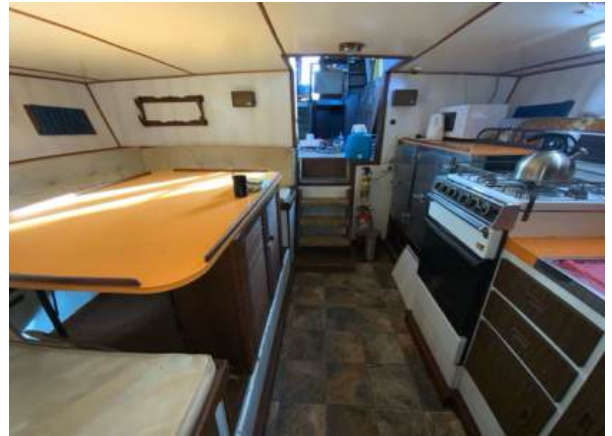
FIT OUT AND FURNISHINGS:

SEATING:	<input checked="" type="checkbox"/>	<input type="checkbox"/>	Acceptable with wear and tear
HEAD LINER:	<input checked="" type="checkbox"/>	<input type="checkbox"/>	Acceptable with wear and tear
HULL LINING:	<input checked="" type="checkbox"/>	<input type="checkbox"/>	Acceptable with wear and tear

DOORS:	<input checked="" type="checkbox"/> <input type="checkbox"/>	Acceptable with wear and tear
FLOOR BOARDS:	<input checked="" type="checkbox"/> <input type="checkbox"/>	Acceptable with wear and tear
CUPBOARD DOORS:	<input checked="" type="checkbox"/> <input type="checkbox"/>	Acceptable with wear and tear
TIMBER TRIMS ETC:	<input checked="" type="checkbox"/> <input type="checkbox"/>	Acceptable with wear and tear
CARPETS	<input type="checkbox"/> <input checked="" type="checkbox"/>	Removed
